**U.S. PUBLIC LAND CORNER  
MAINTENANCE**

**Corner ID : S1/4 Sec.31, T16N-R1E**

**41601310020**

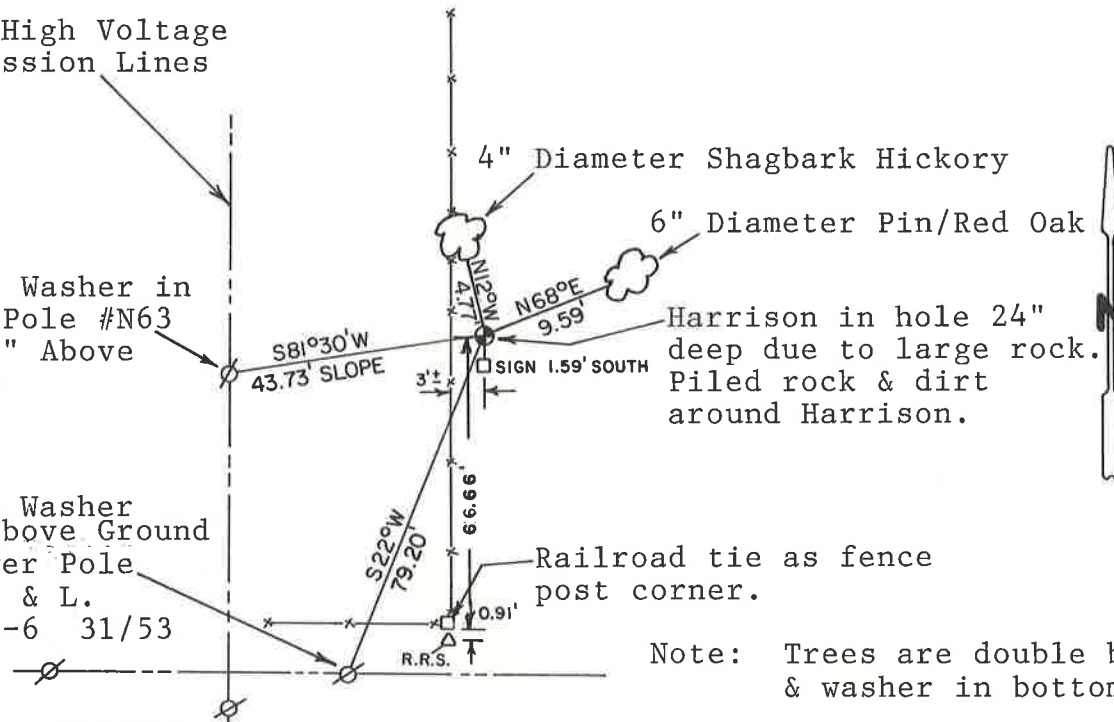
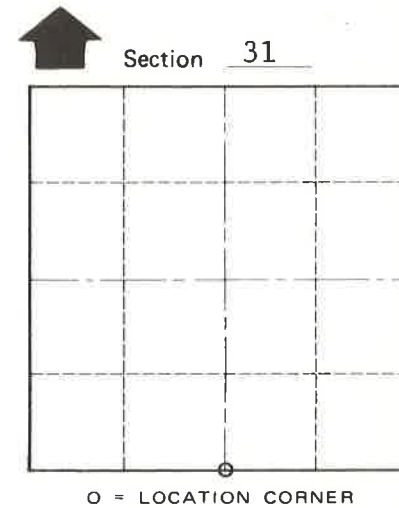
Used North-South fence and a straight line between the SE and the Southwest corners of Section 31. The half-mile distances check well in comparison to prorating the South line.

Harrison in hole 24" deep due to large rock. Piled rock & dirt around Harrison.
