**U.S. PUBLIC LAND CORNER
MAINTENANCE**

Corner ID : SE Sec. 7, T16N-R2W

~~City Village or~~ Town Ridgeville
County of Monroe
Wisconsin

COUNTY SURVEYOR FORM NO. 1

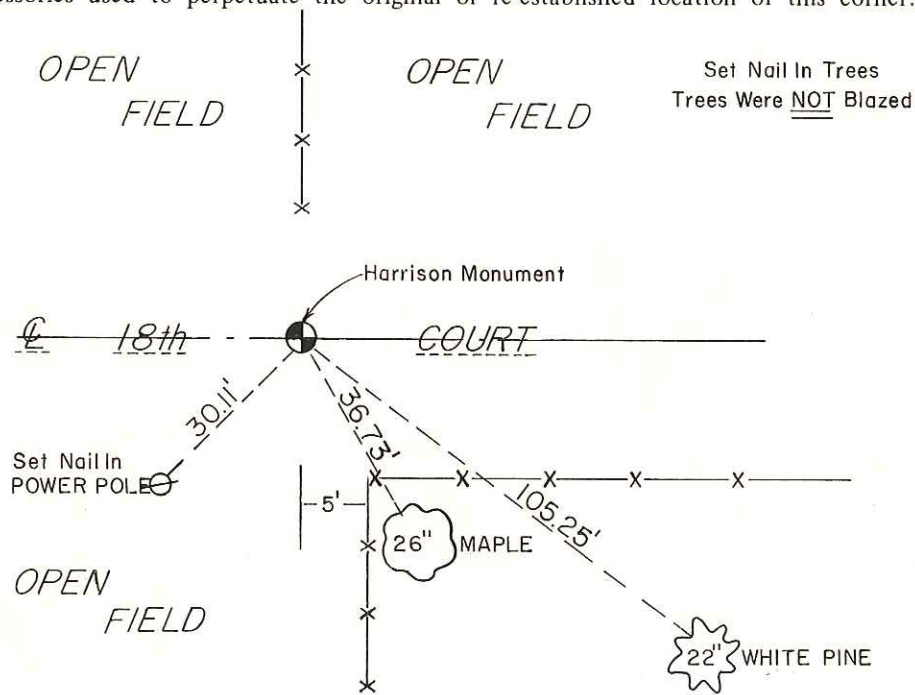
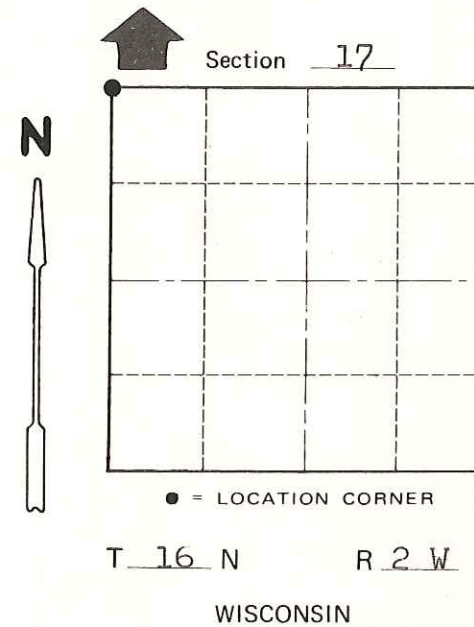
Description of corner and witness monuments, references and accessories used to perpetuate the original or re-established location of this corner:

Found Marten's iron bar and replaced it with a Harrison monument.
