U.S. PUBLIC LAND CORNER MAINTENANCE

Corner ID: W1/4 Sec.5, T17N-R1W

21701062000

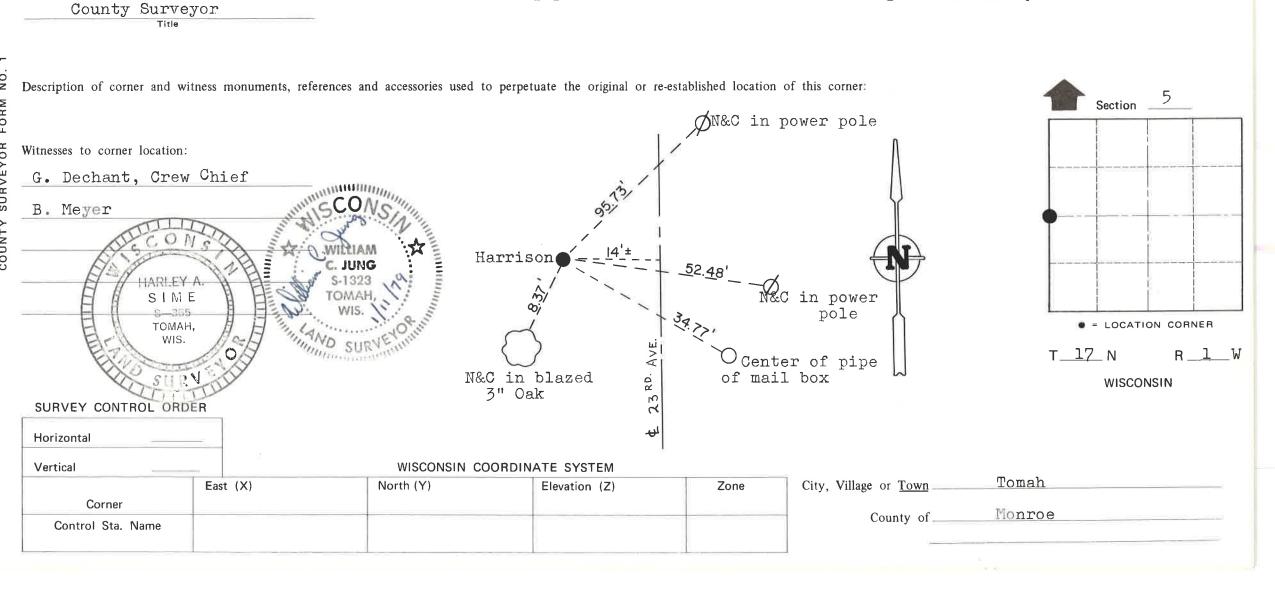
Found iron pipe and replaced it with a Harrison Monument.

The iron pipe had been used as the corner in previous survey work.
