U.S. PUBLIC LAND CORNER MAINTENANCE

Corner ID: S1/4 Sec. 23, T17N-R4W

CERTIFIED LAND CORNER

No. 84

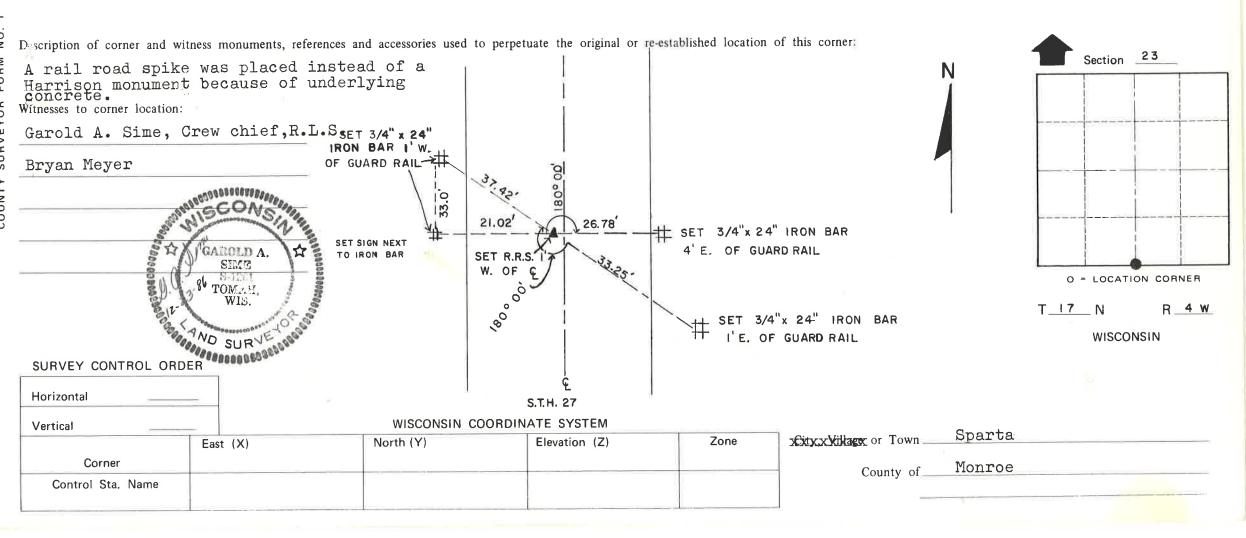
Monument and ties where destroyed during road reconstruction. Set corner at previously computed location.

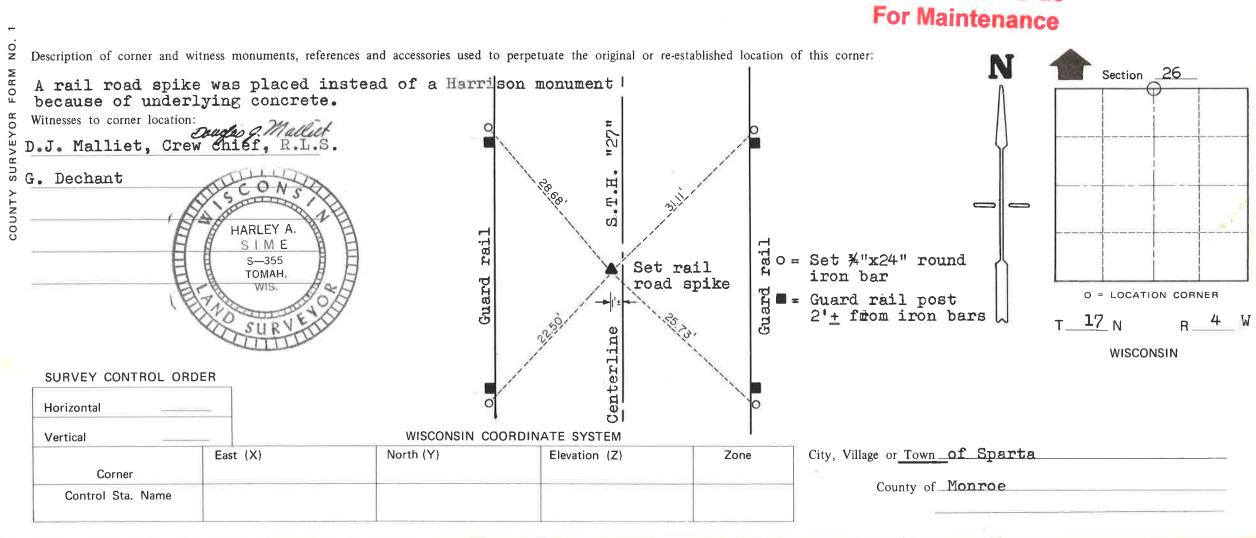
Did not find the iron pipe described as being located at this corner. Re-set this corner by D.L. Mulock's ties to this corner from his plat of survey.
