**U.S. PUBLIC LAND CORNER  
MAINTENANCE**

**Corner ID : E1/4 Sec. 29, T18N-R3W  
21803292000**

City, Village or Town of LAFAYETTE

COUNTY SURVEYOR FORM NO. 1

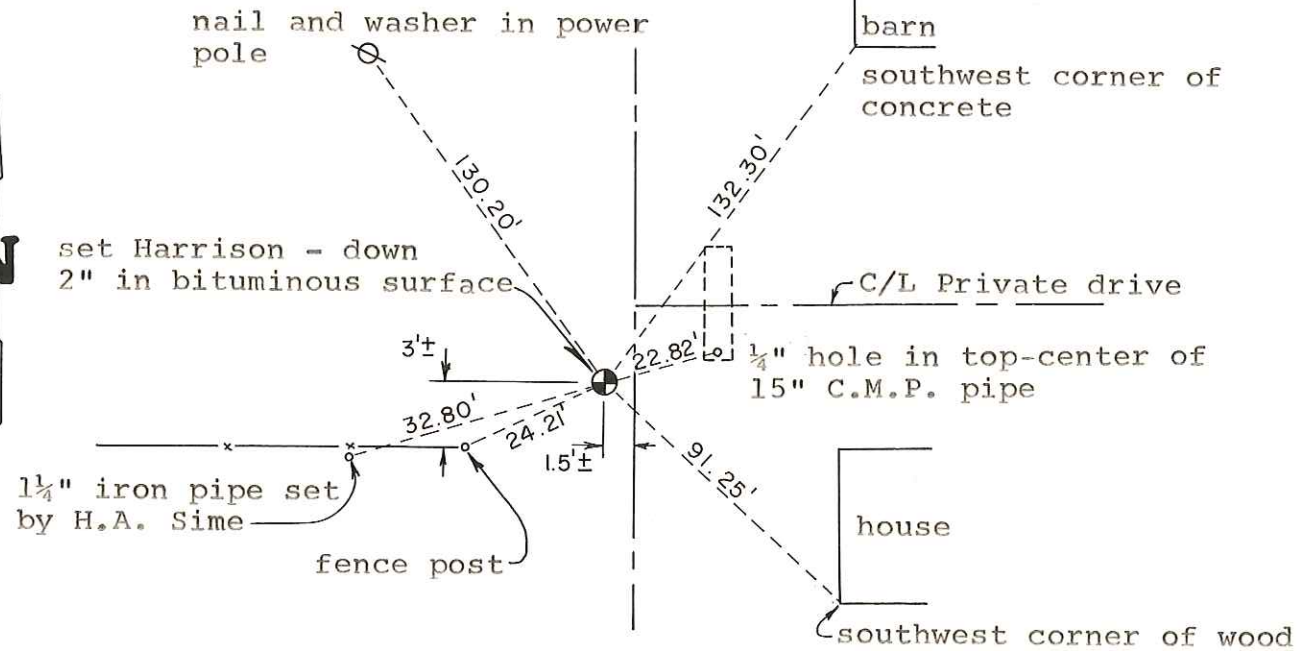
O = LOCATION CORNER  
T 18 N R 3 W  
WISCONSIN

We found the iron pipe, however, it did not agree with Henschow's recorded 1/2 mile distances North, South, and East to the C 1/4 corner of Section 28. The iron pipe is in the East-West fence, which itself, proves to be nearly midway between the section corners, however, the pipe is almost 33' West of where it is purported to be according to measurements to the C 1/4 corner of Section 28. We looked 33' East of the iron pipe, but did not find another iron pipe. The corner was re-established on line and midway between the NE & SE section corners. This location agrees very well with Henschow's distance from the C 1/4 corner of Section 28. This location agrees with a now lost bearing tree of record (Holden's), whose former location was (OVER)----
