U.S. PUBLIC LAND CORNER MAINTENANCE

Corner ID: NE Sec. 34, T19N-R1W

21901270000

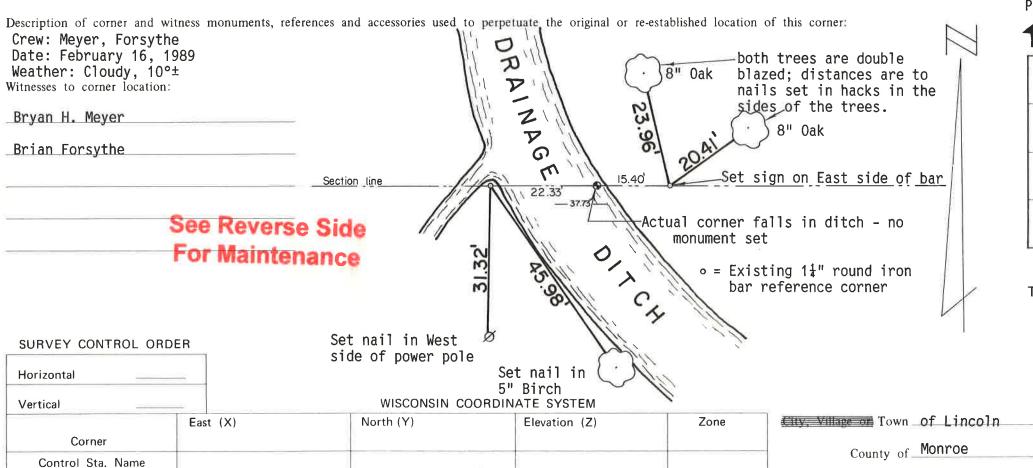
I tied into Mr. Malliet's reference markers to help me establish the East ½ corner of Section 34. I found that 2 of 3 of Mr. Malliet's ties to the reference corners were gone (the power pole had been replaced; the Jack Pine had been cut down). I got new ties to the reference markers as shown below.
