U.S. PUBLIC LAND CORNER MAINTENANCE

Corner ID : SE Sec.9, T19N-R1W

U. S. PUBLIC LAND SURVEY MONUMENT RECORD

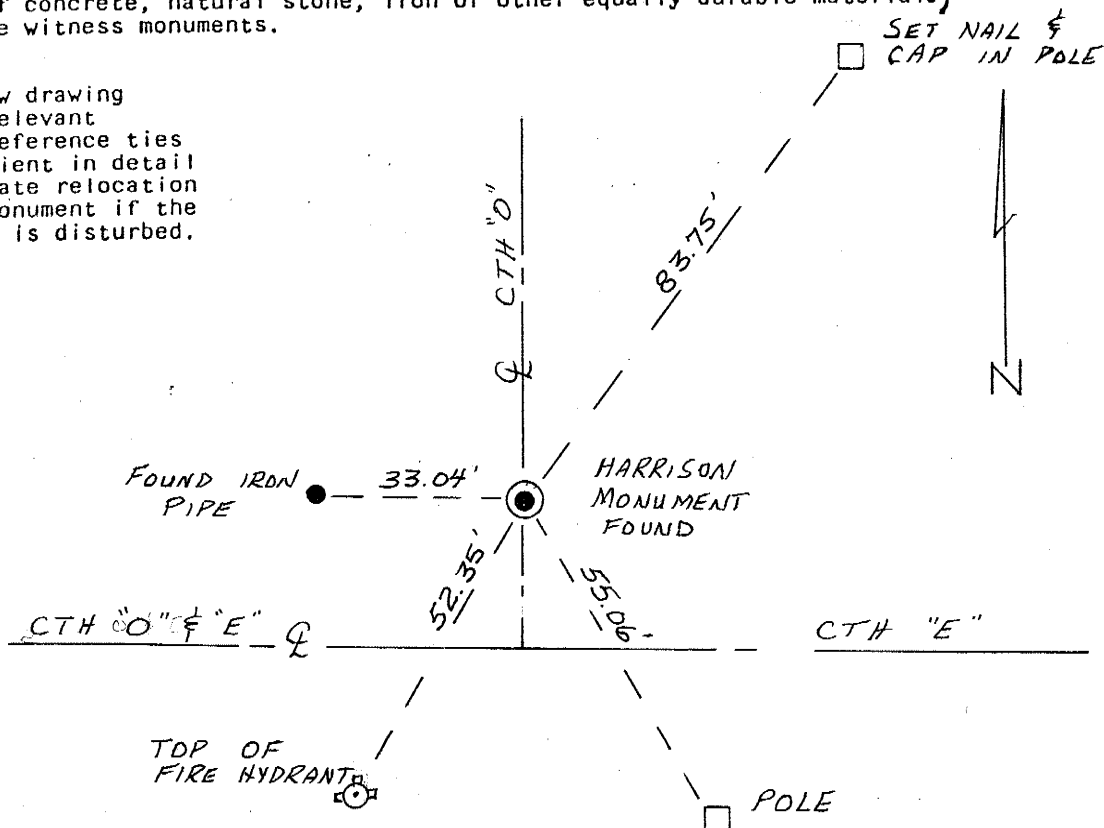
The Harrison monument at this corner and three witness monuments were found on March 30, 1993 by Michael L. Deems. (See previous Certified Land Corner record by Harley A. Sime dated March 2, 11976). One additional witness monument was set as shown below.

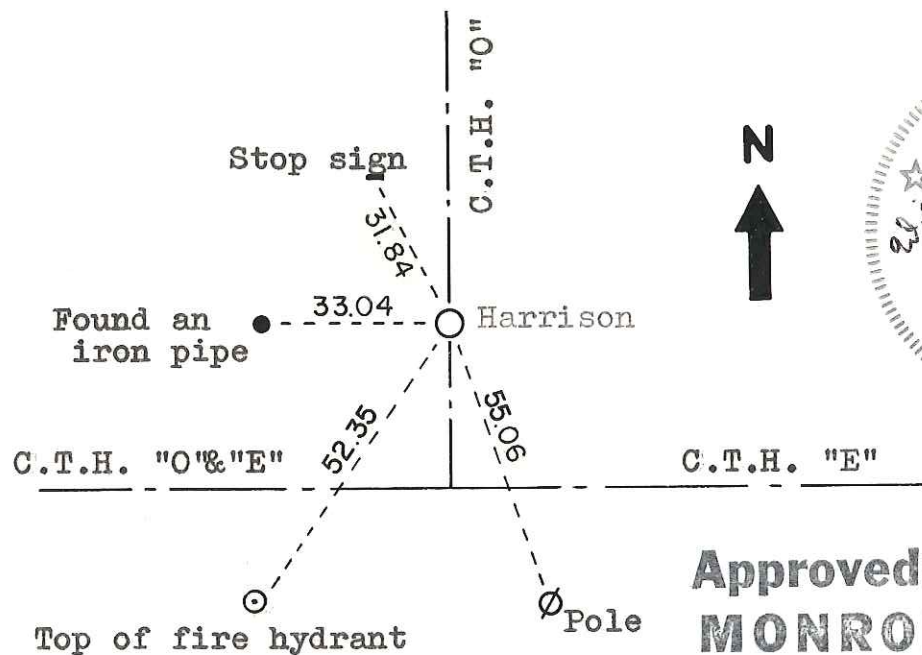
Found a 1" iron pipe that had been used in several previous surveys. Removed the pipe and replaced it with a Harrison marker.

This corner as set fits the old plat and the R.R. maps very well.

Set a Harrison in the road, down 6".

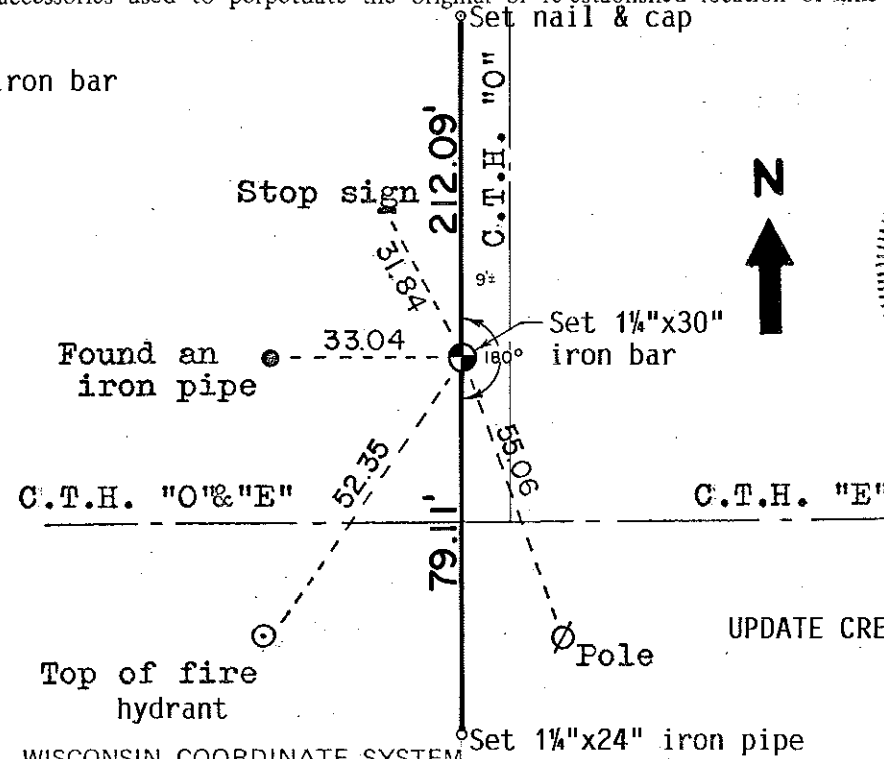
The January, 1894 Plat of Warrens, shows this corner as a 4x4 oak post. The old R.R. R/W maps also make reference to this corner. UPDATE: The County Surveyor's Office was contacted by Norb Smith, Monroe County Highway Commissioner, that this portion of C.T.H. "E" was to be upgraded and repaved. The Harrison marker was removed July 7, 1992.

This corner as set fits the old plat and the R.R. maps very well. UPDATE: Following construction, this corner was reset with a 1 1/4"x30" round iron bar in the new hot-mix paving. This corner was reset using the nail & cap and the 1 1/4" iron pipe shown. Did not verify any of the other ties or distances to them. (The nail and cap and the 1 1/4" iron pipe shown were set at the time the Harrison

*UPDATE: Removed Harrison; set 1 1/4"x30" round iron bar
