## U.S. LAND CORNER MAINTENANCE

Corner ID: E1/4 Sec. 22, T18N-R1E

41801222000

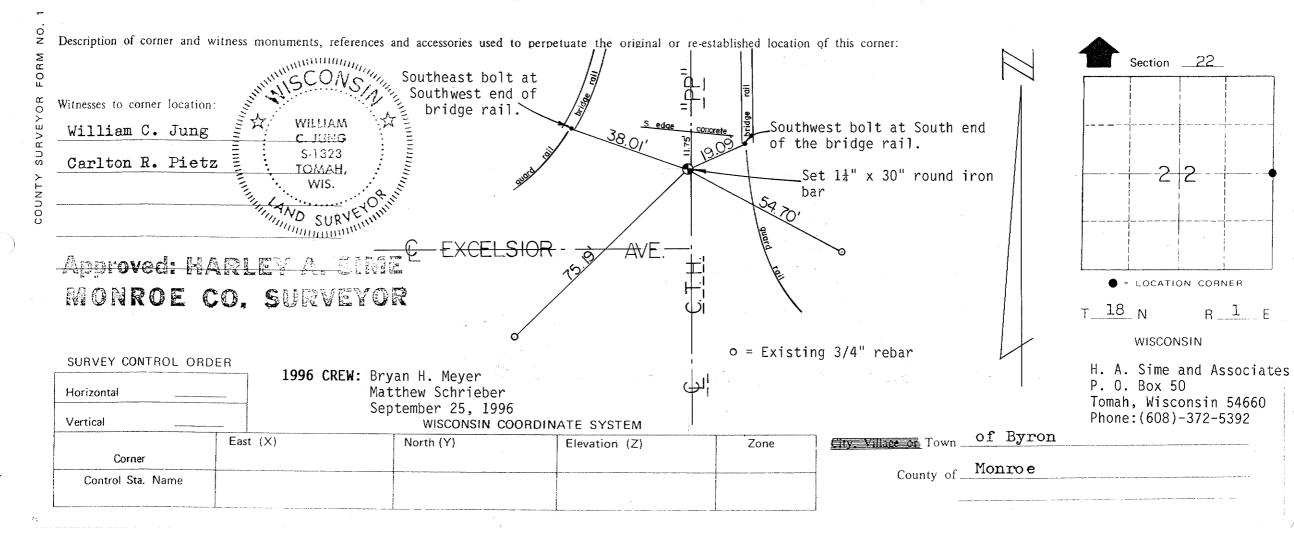
1996 UPDATE: This corner was in danger of being destroyed when the bridge just to the North was to be replaced. On March 12, 1996 new ties were taken and the Harrison removed. On September 25, 1996, a  $1\frac{1}{4}$ " x 30" round iron bar was set at the corner location and newer ties were taken as illustrated below.
