# **MOCO LCD 2021 Stream Crossing Assessment**

Mykel Yancey and Lily Adams

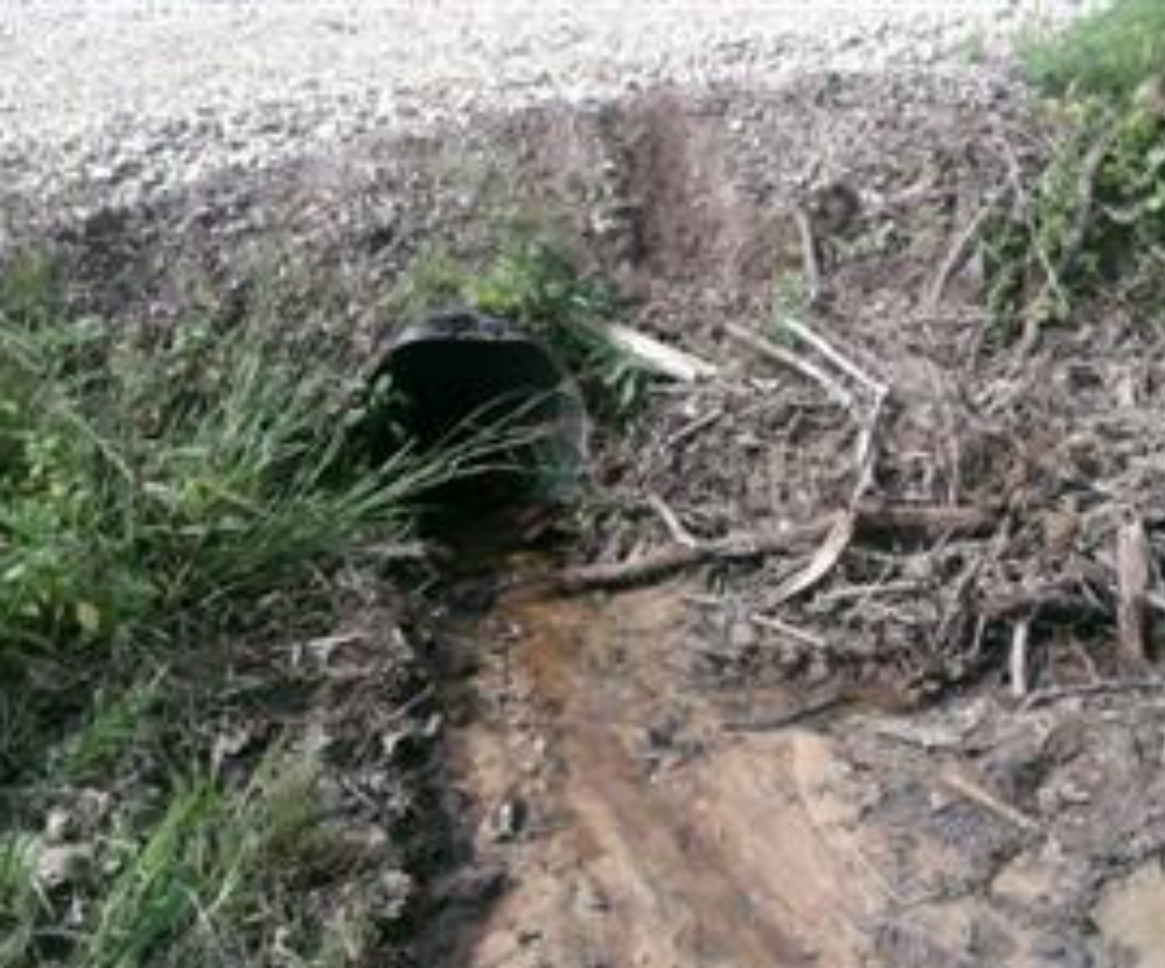
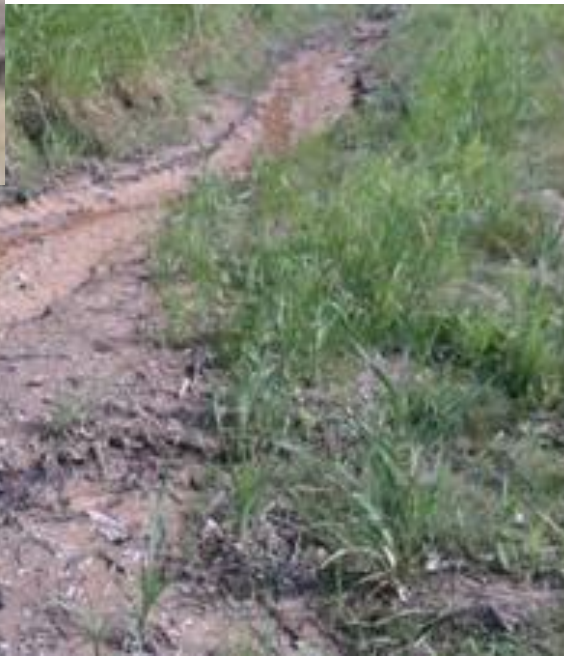
# Marigold Rd

Poor unprotected  
embankments

Perch height: 4.5  
ft.

Flood Resiliency: ✘

Fish Passability: ✘

Road Safety: ✔

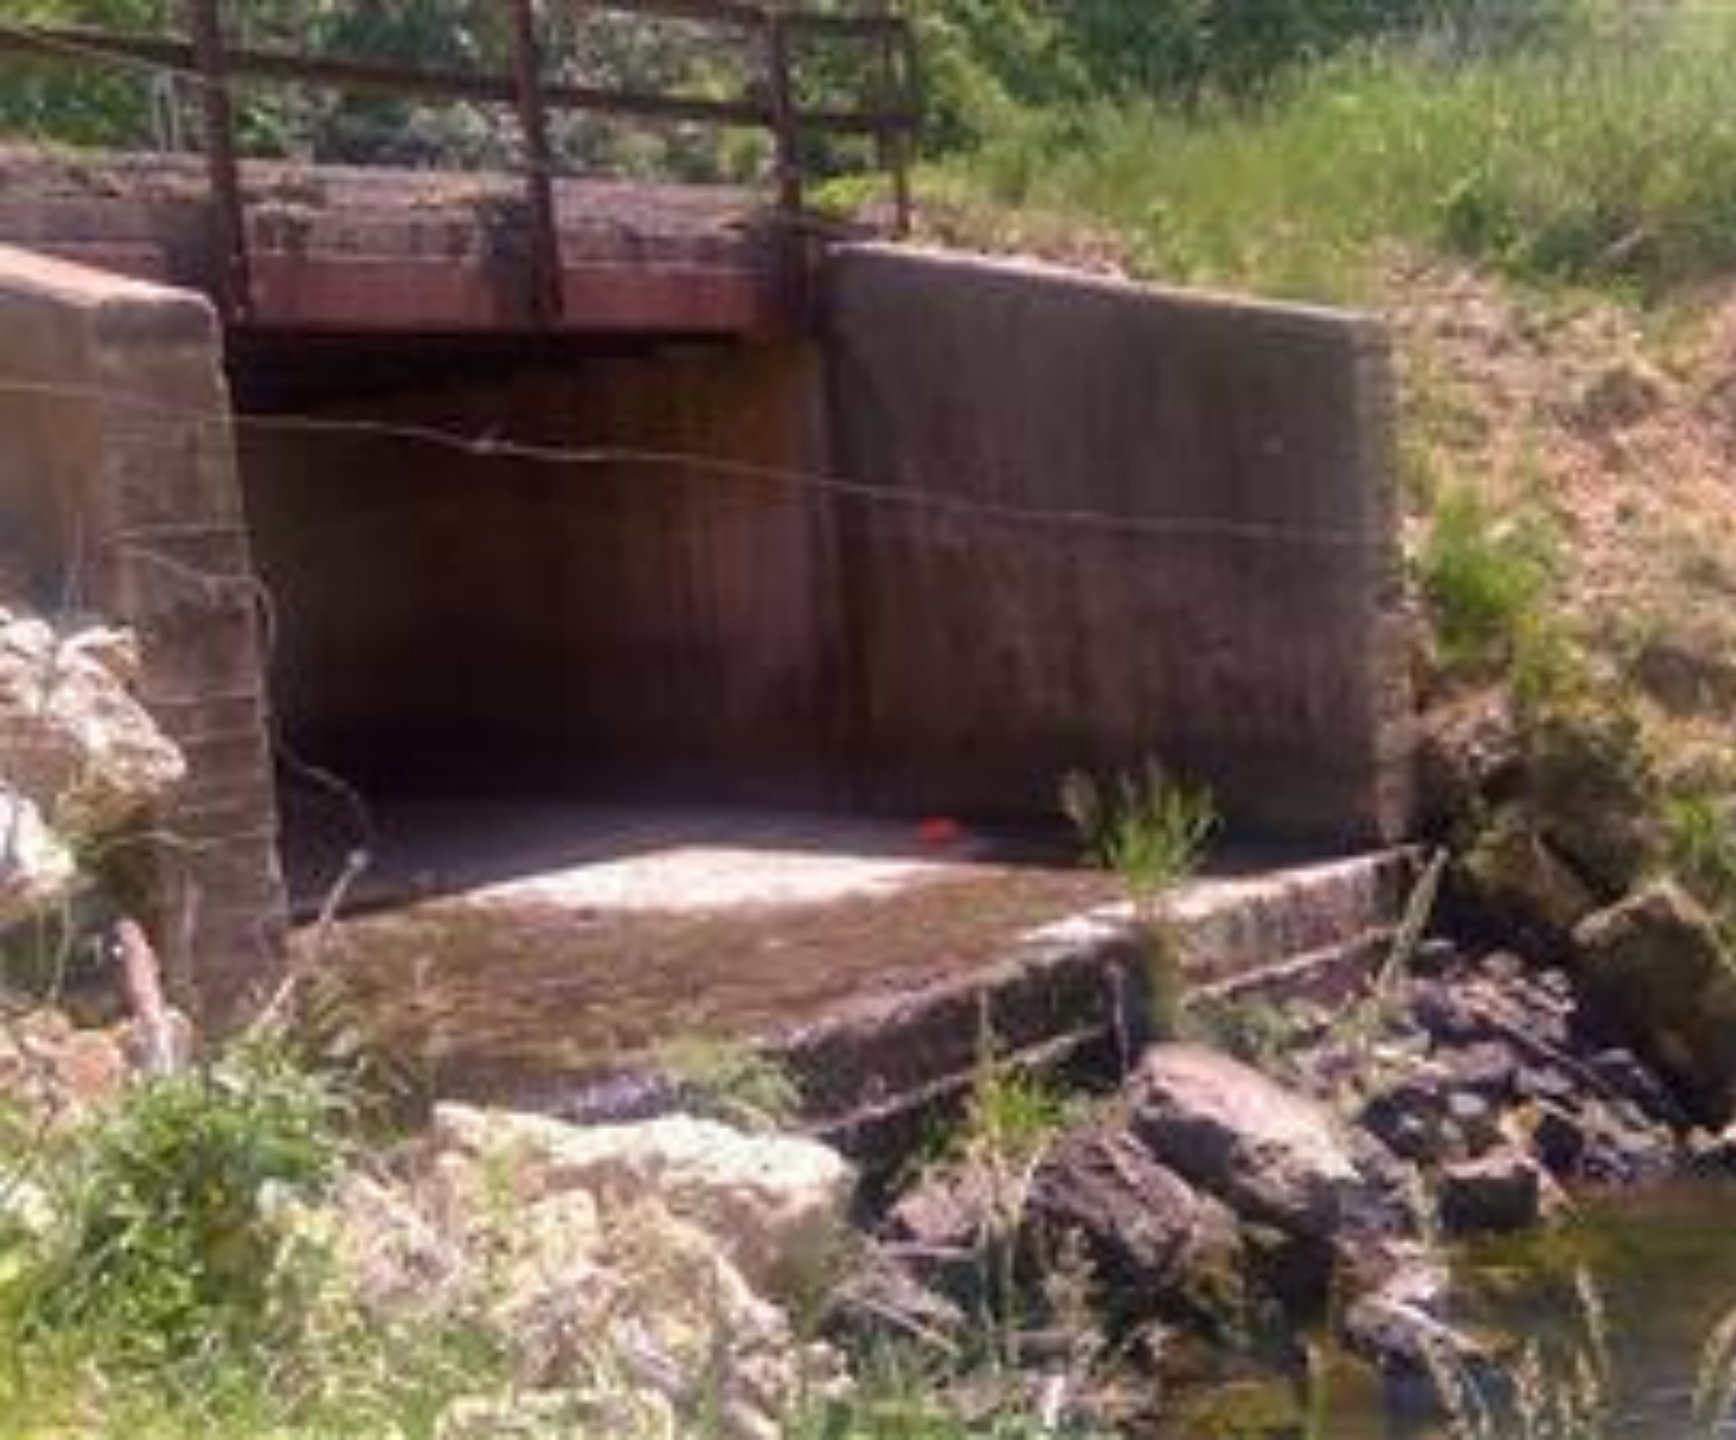
# Mentor Rd

Extreme woody debris buildup at inlet

Flood Resiliency: ❌

Fish Passability: ❌

Road Safety: ✅

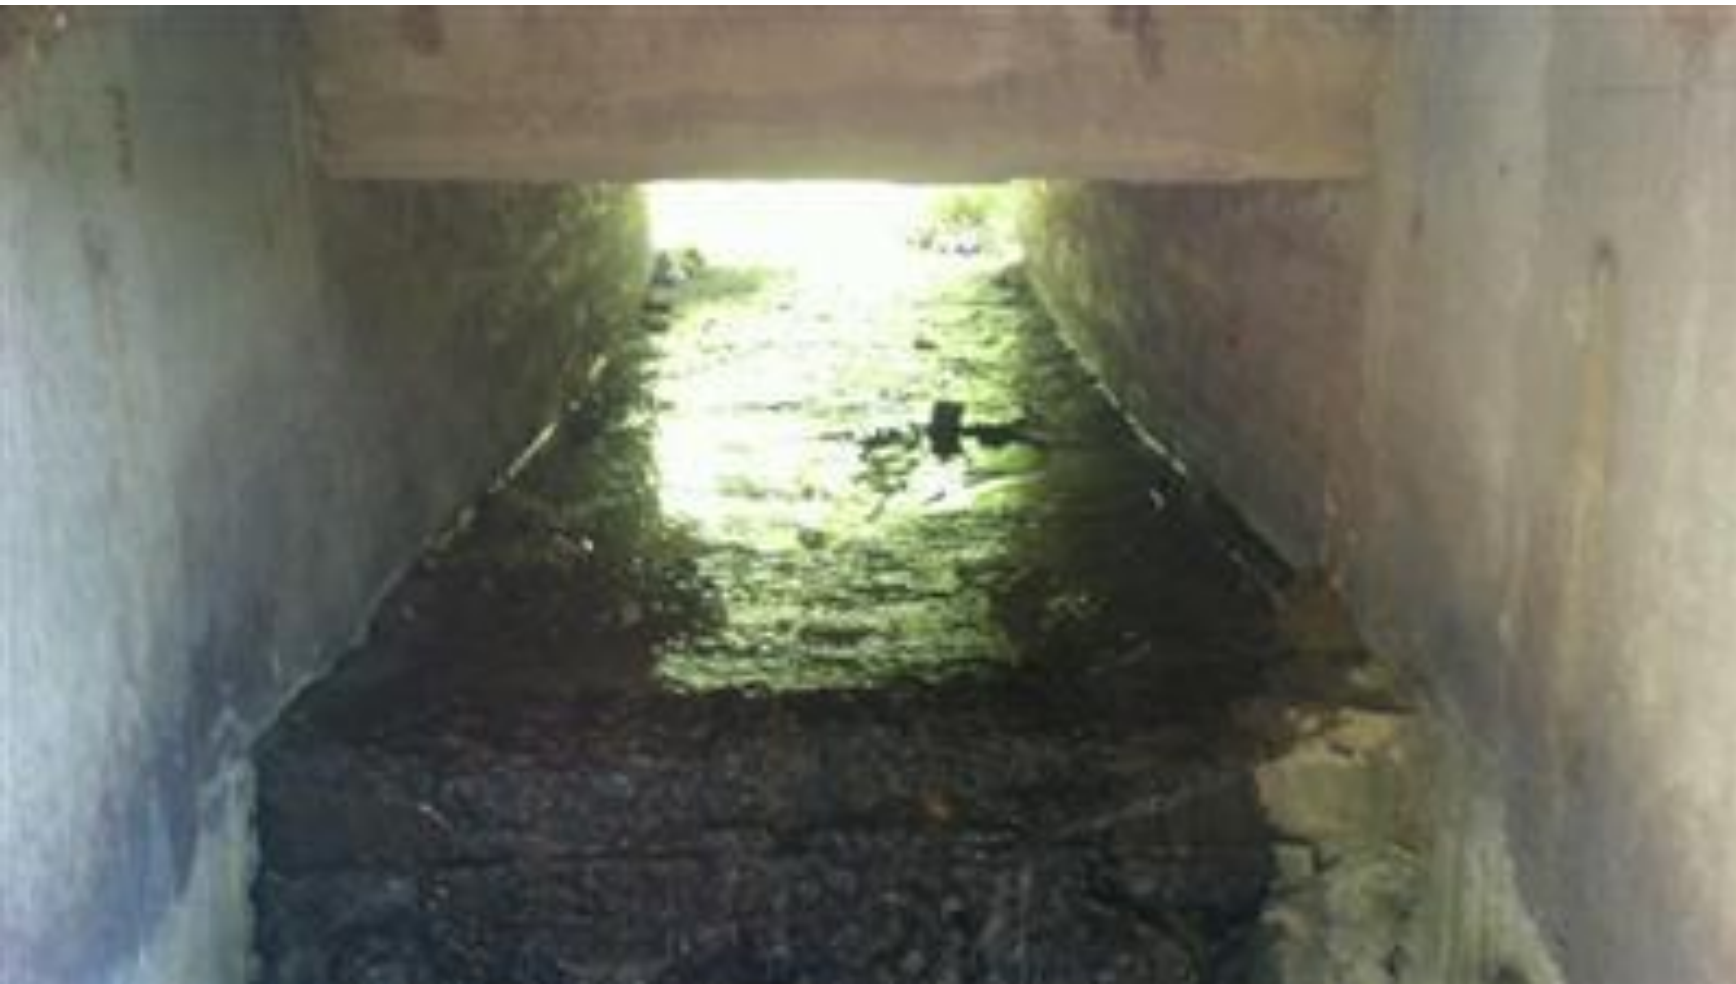
# County PC

Water depth: .08 ft.

Perch height: 3.2 ft.

Flood Resiliency: ✓

Fish Passability: ✗

Road Safety: ✓

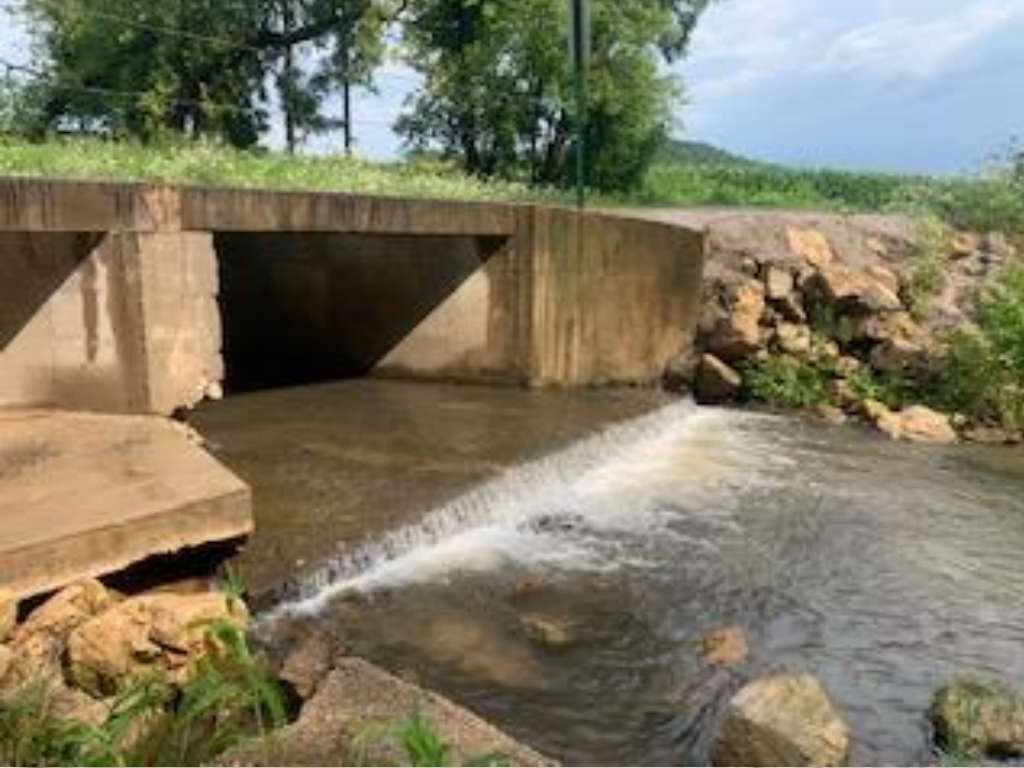
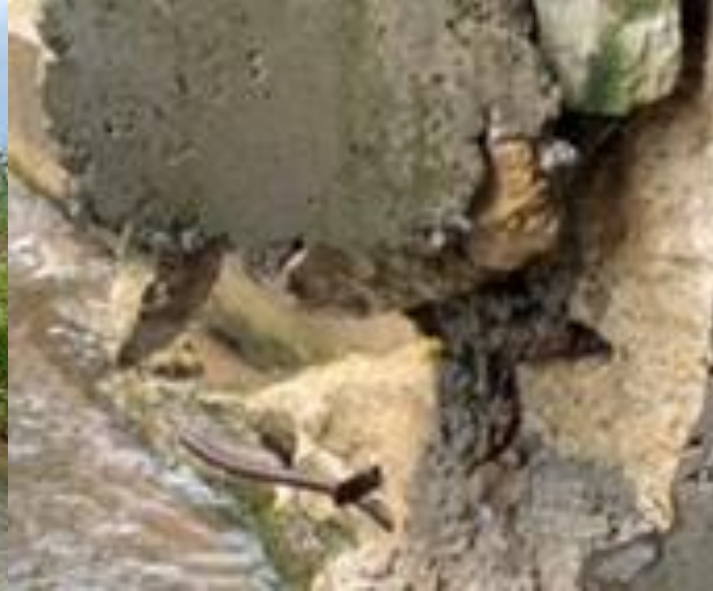
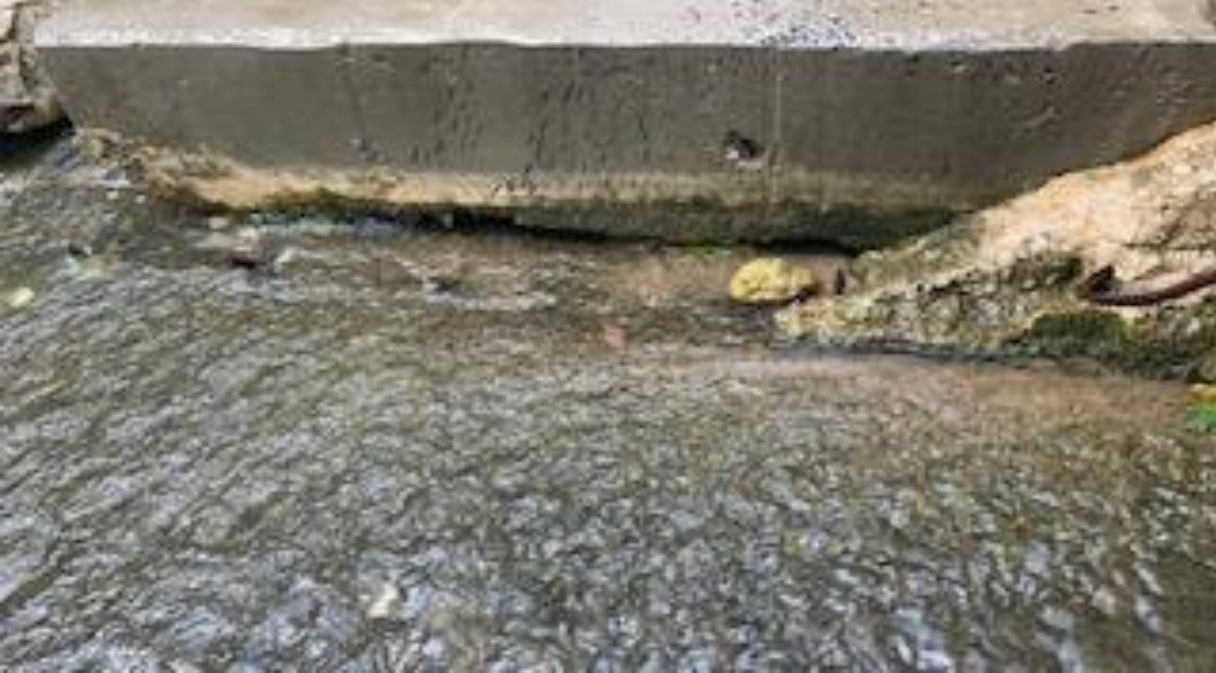
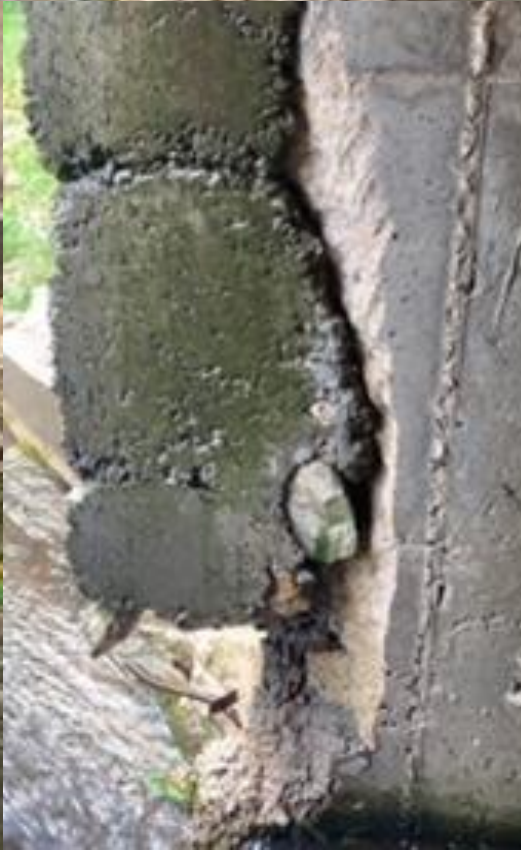
# Midway Rd

Water depth: .01 ft.

Inside perch height:  
2.7 ft.

Flood Resiliency: ✓

Fish Passability: ✗

Road Safety: ✓

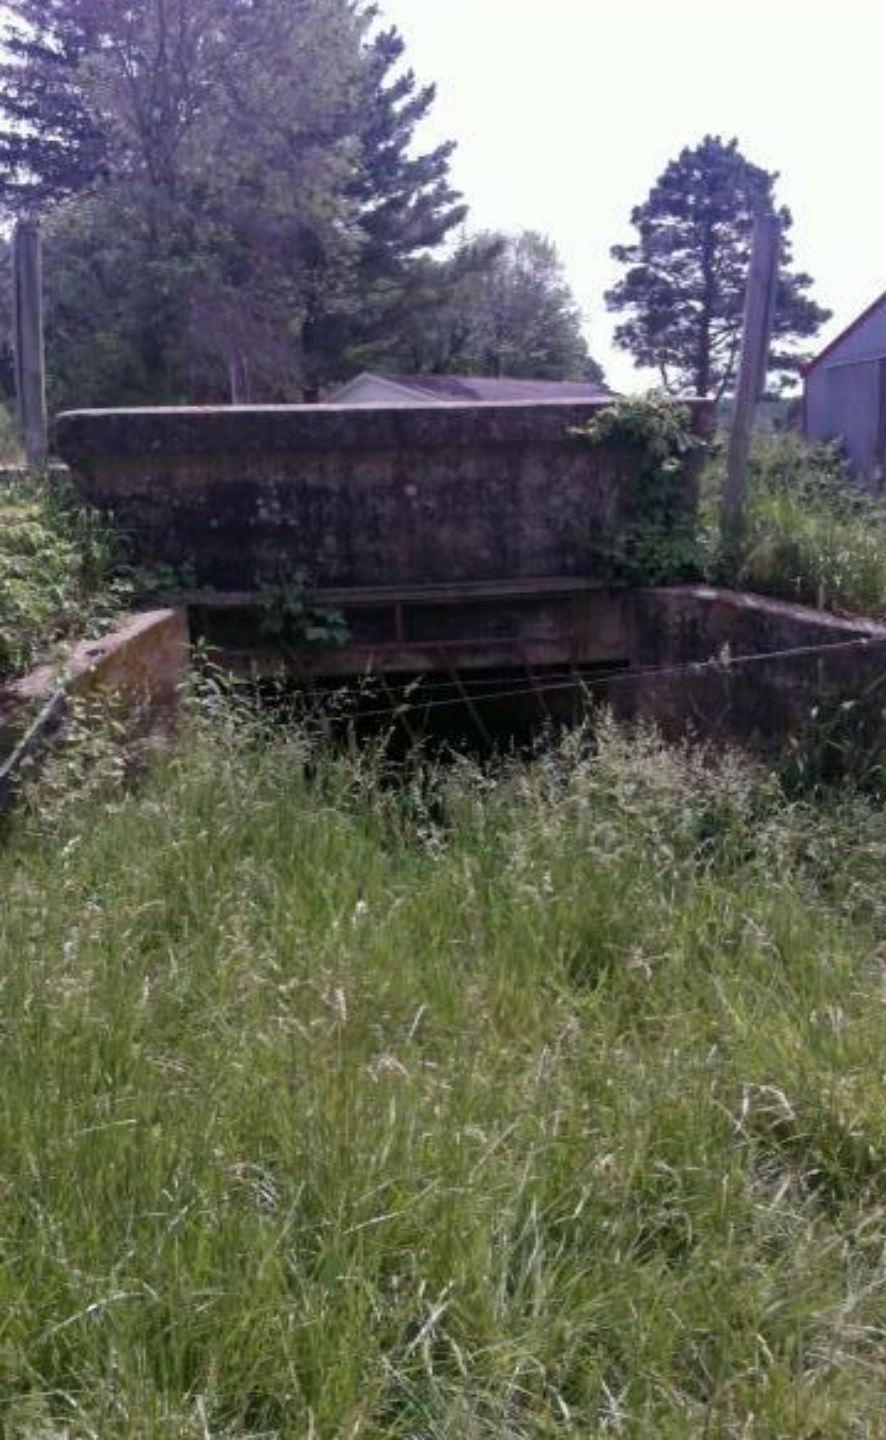
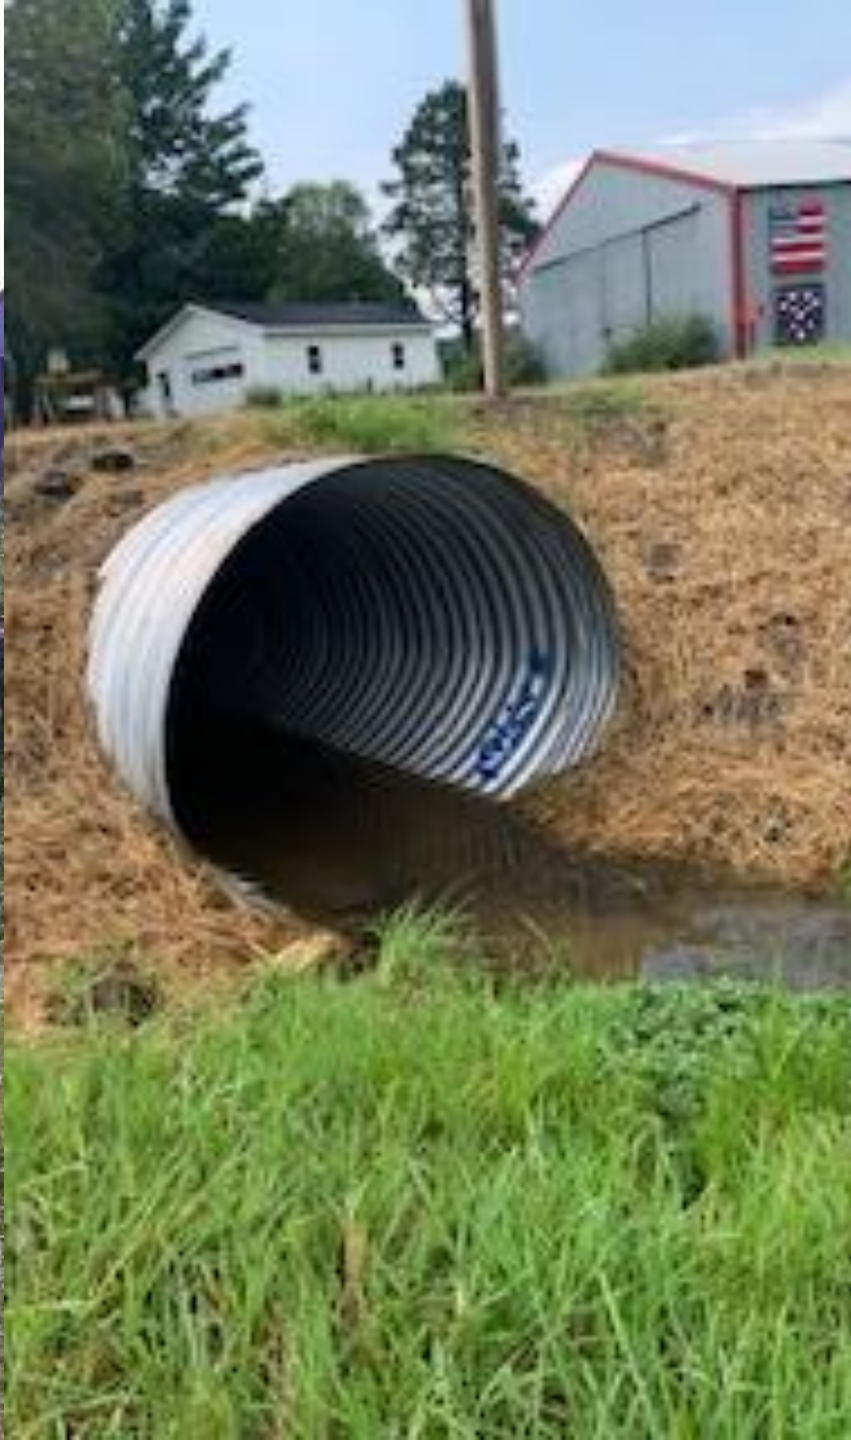
# Market Rd

Deterioration

Perch

Undermine of high relief structure

Replaced three times
