MoCo LCD 2022 Stream Crossing Assessments

Helena Wehrs and Brandon Thill

Objective

Evaluate stream crossings for fish passage and flood resiliency in Monroe County with criteria from the Great Lakes Stream Crossing Inventory.

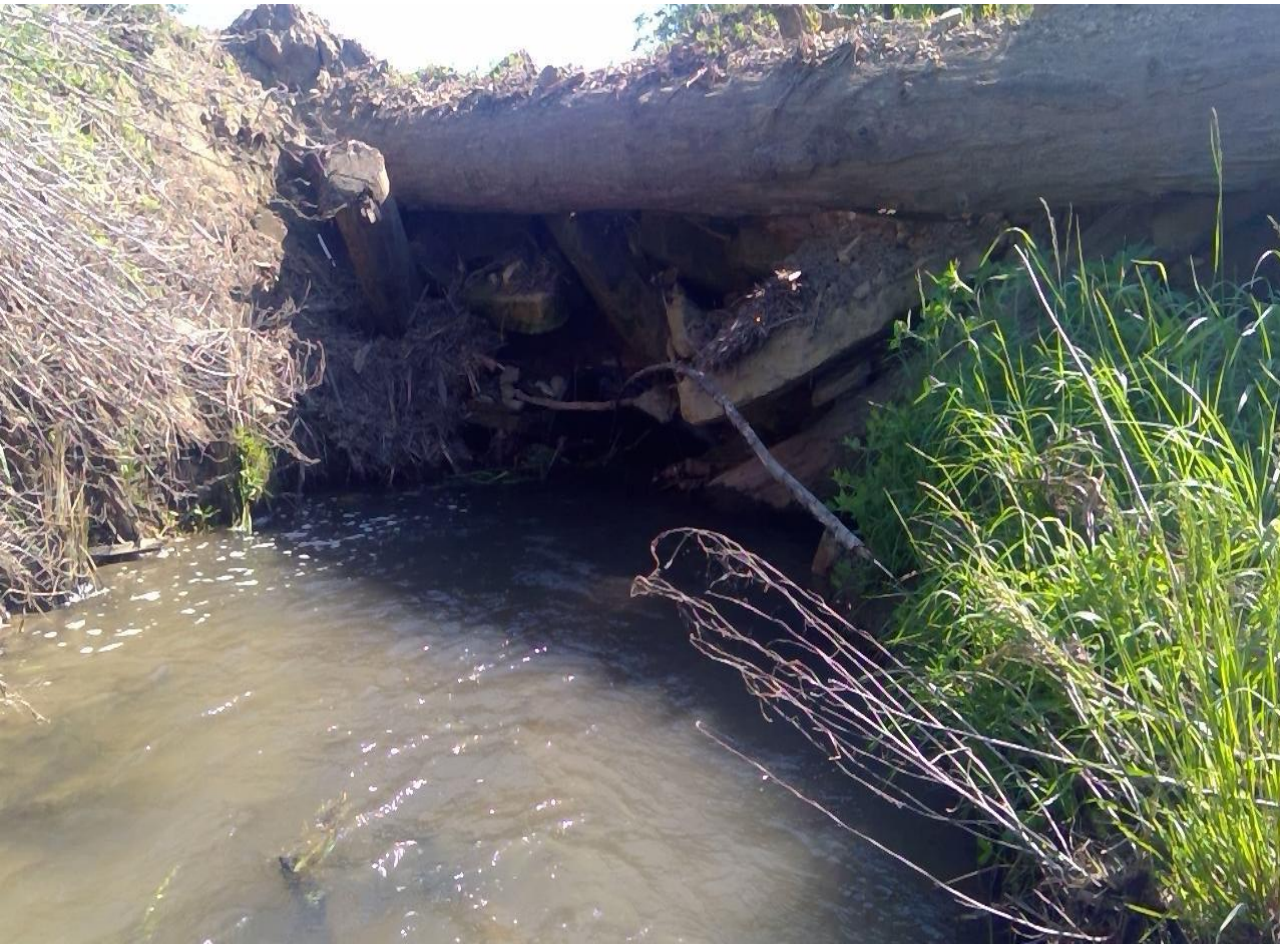
Inlet

Severe Deterioration

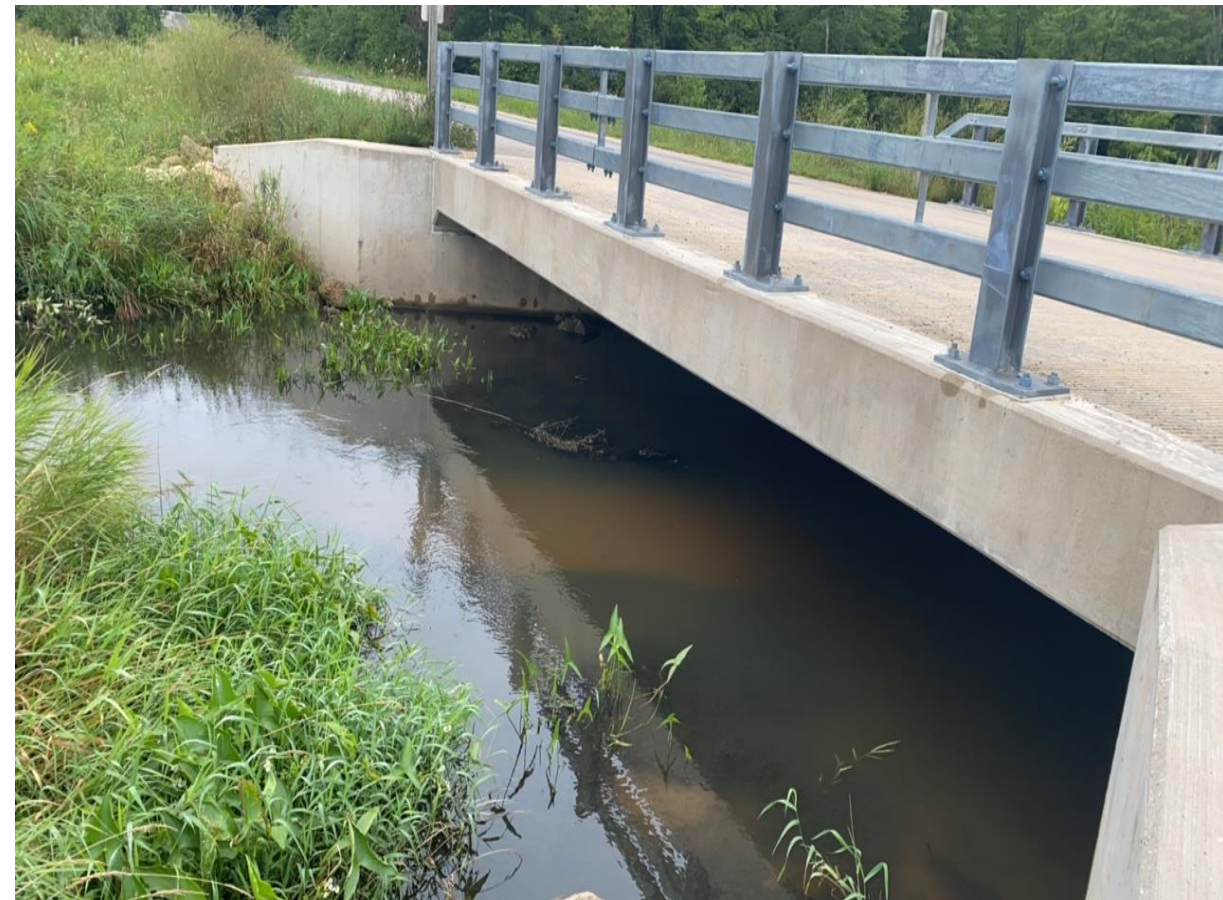
Inlet

New Structure
