MOCO LCD 2021 Stream Crossing Assessment

Mykel Yancey and Lily Adams

- Using ArcGIS software, conduct assessments of all water crossings in the Southern townships (highest rate of damage from 2018 and 2019 flood events) to help delegate areas of destruction in highest need of reconstruction
 - Portland, Jefferson, Sheldon, Wellington, Glendale, Ridgeville, Wells, and Leon

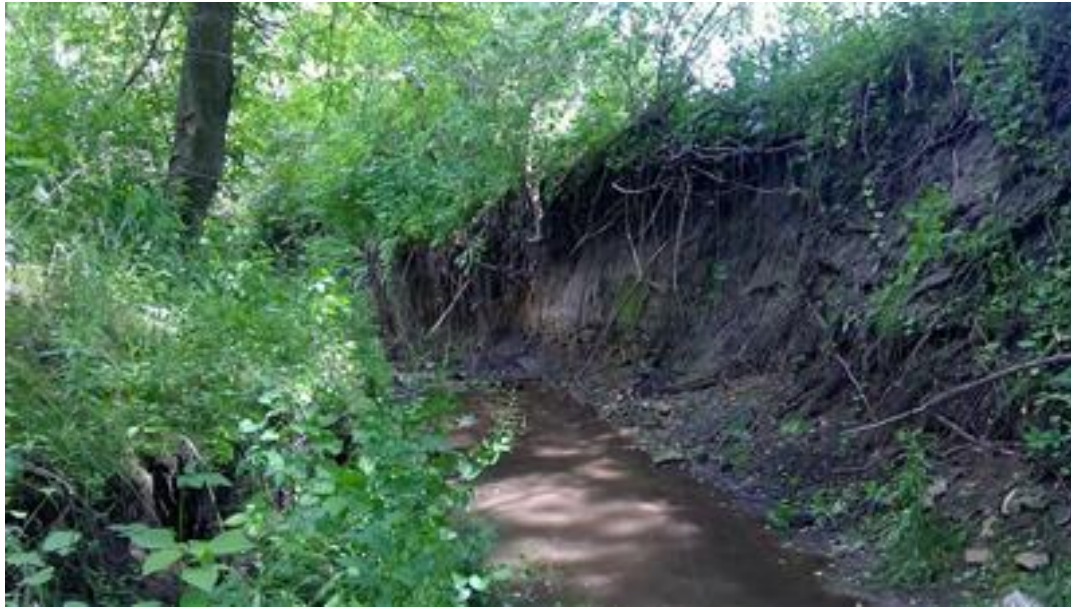
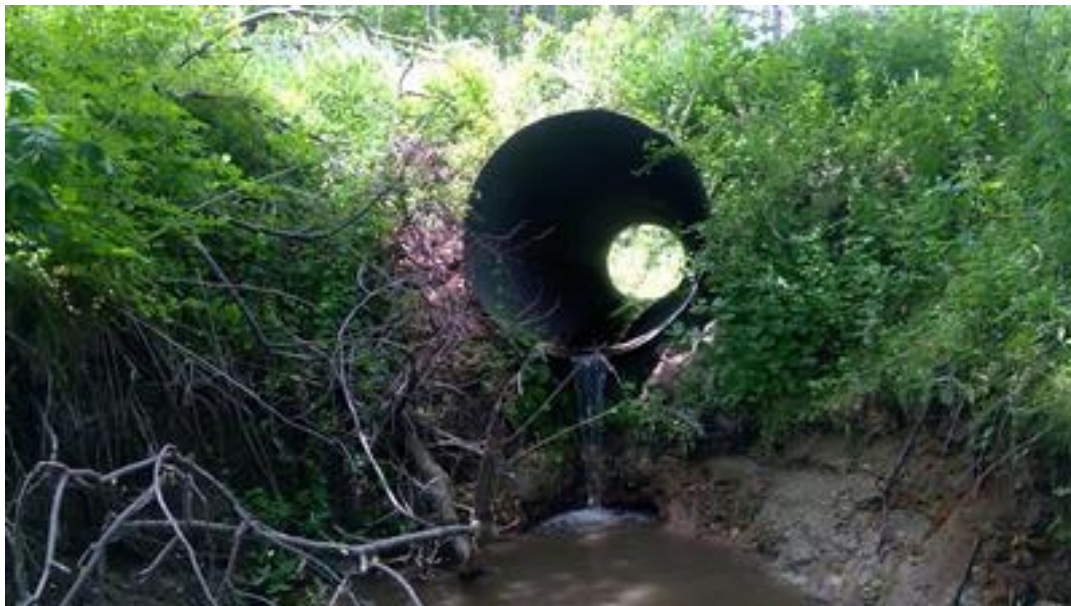
Marigold Rd

Poor unprotected
embankments

Perch height: 4.5
ft.

Flood Resiliency: ✘

Fish Passability: ✘

Road Safety: ✔

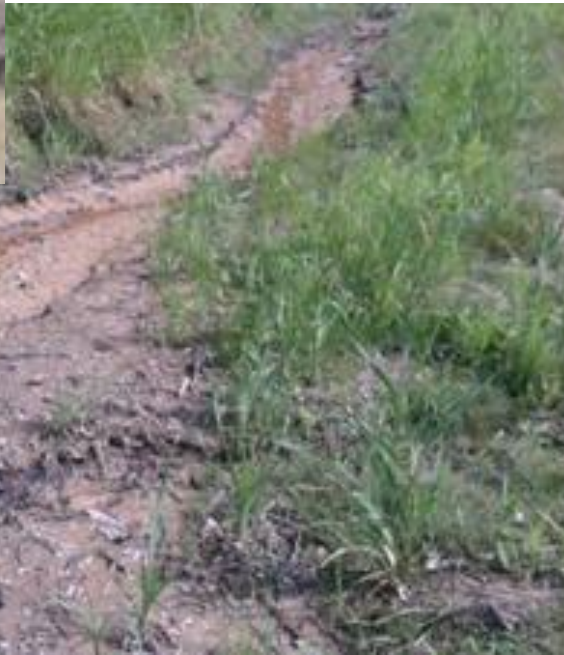
Mentor Rd

Extreme woody debris buildup at inlet

Flood Resiliency: ❌

Fish Passability: ❌

Road Safety: ✅

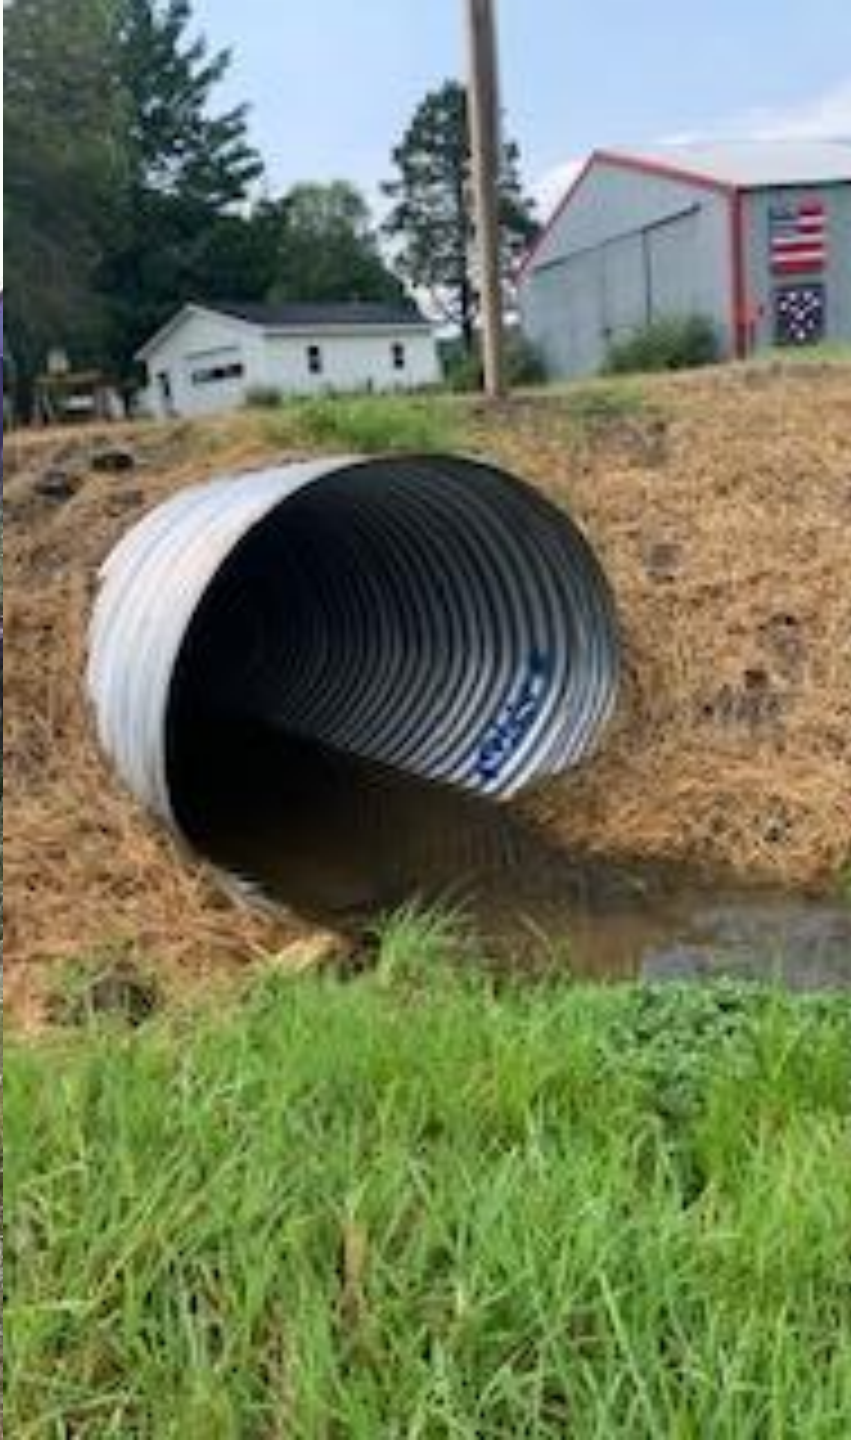
Nebraska Rd

Ideal size: 7.3 ft.

Past size: 7.28 ft.

Current size: 6.3 ft.
