JACKSON COUNTY – U.S. PUBLIC LAND SURVEY MONUMENT RECORD

CORNER VOL. 4, PAGE 502
 CORNER# 22004350000
 SECTION 36, T 20 N, R 4W

Government Land Corner Certificate

Jackson County

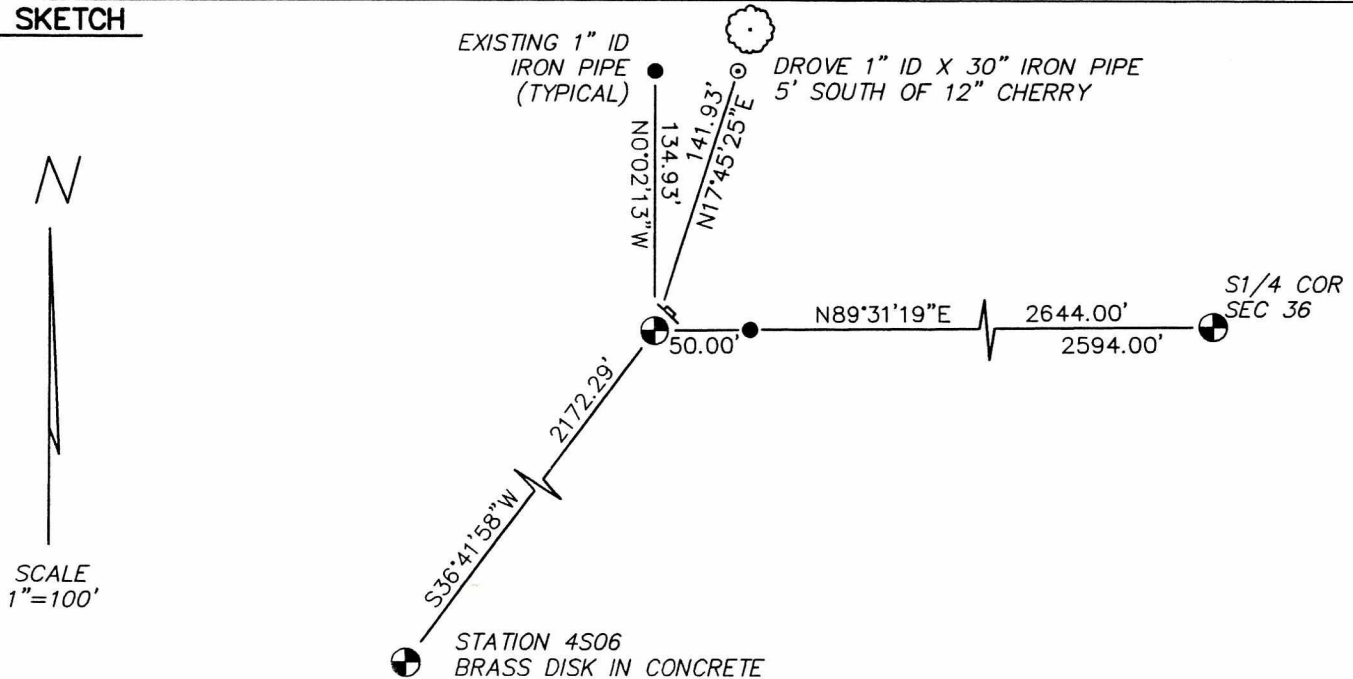
TIE SKETCH

We found the BCP partially heaved up and the stone lying flat on the south side of it. When we plumbed the pipe, we found it to fit the corner location nearly perfectly based on the reference pipe to the east. We drove it down within 6 inches of the ground surface and accepted it as the corner. The sign post had heaved up some, so we drove that down also.

The corner is wide open for GPS observations.

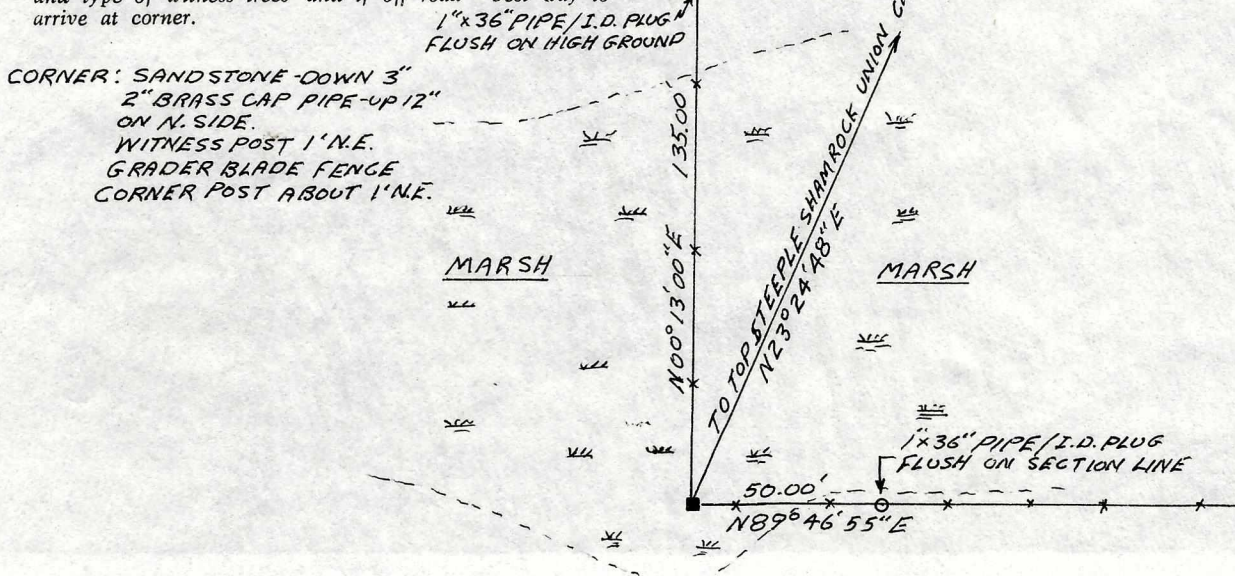
TIE SKETCH SCALE 1" = 50'

County Surveyor C.M. Keach, in County Survey Record No. 656 made in 1909 and recorded in Vol. 2 at page 390 states, "Original lost - Restored in town line midway on line between 1/4 corners and set stone 17 x 12 x 4."

I first found this stone in a survey for the Town of Manchester Garage Lot in 1954. At that time I set stamped cap pipe on N side for reference.
