U.S. Public Land Survey Monument Record

Corner ID: E1/4 Sec. 16, T15N-R1W

U. S. PUBLIC LAND SURVEY MONUMENT RECORD

SECTION 16, T15N, R1W, TOWN OF WELLINGTON MONROE COUNTY, WISCONSIN

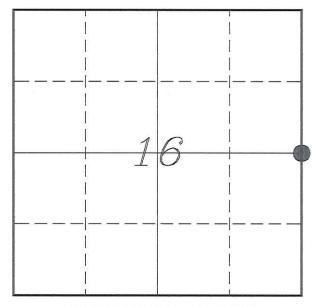
LOCATION OF LANDMARK

Northing	318572.488		
Easting	710146.086		
Datum	NAD 1983 (1991)		
Elevation			
Datum			
TYPE OF LANDMARK: Set Harrison Monument			
BEARINGS ARE REFERENCED TO:			
Monr	oe County Coordinates

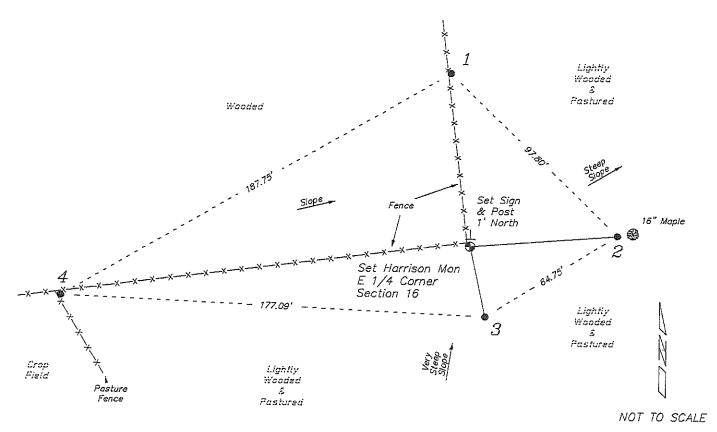
PLAN VIEW DRAWING OF REFERENCE TIES

NO	DESCRIPTION	BEARING	DISTANCE
1	Set 3/4" x 18" Iron Rod In Fence Line	N 06°31'07" W	73.63'
2	Set 3/4" x 18" Iron Rod 2' West of a 16" Maple	N 85°33'37" E	61.76'
3	Set 3/4" x 18" Iron Rod On Steep Side Slope	S 12°32'54" E	30.00'
4	Set 3/4" x 18" Iron Rod In Fence Line	S 82°45'16" W	171.78
