**U.S. PUBLIC LAND CORNER
MAINTENANCE**

**Corner ID : E1/4 Sec. 21, T17N-R4W
21704212000**

CERTIFIED LAND CORNER

No. 77

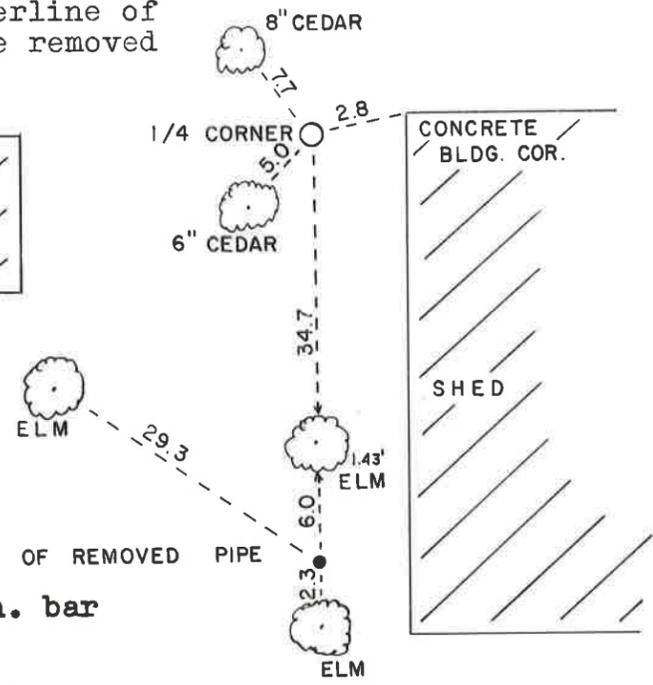
POSITION OF REMOVED PIPE

A 1 1/2" iron pipe was found that had been used as the 1/4 corner by Duane Marten in a previous certified survey. An old local farmer said the pipe had been there over 30 years. He didn't know how it had got there though. The pipe was not on record, no other surveys were tied to it besides Marten's, nor could we find any information about it on old highway R/W maps or in old deeds in the courthouse. Aerial photos, evidence in Section 21, and information from an 1895 survey by Henry Schroeder showed that the corner should move North. Using the latter points, the corner was moved North to its present position. The iron pipe was removed to avoid future confusion. Ties for its old position are also shown below.

Note: The elms used as ties for the pipe have nails and caps in them.
