MoCo LCD 2022 Stream Crossing Assessments

Helena Wehrs and Brandon Thill

Objective

Evaluate stream crossings for fish passage and flood resiliency in Monroe County with criteria from the Great Lakes Stream Crossing Inventory.

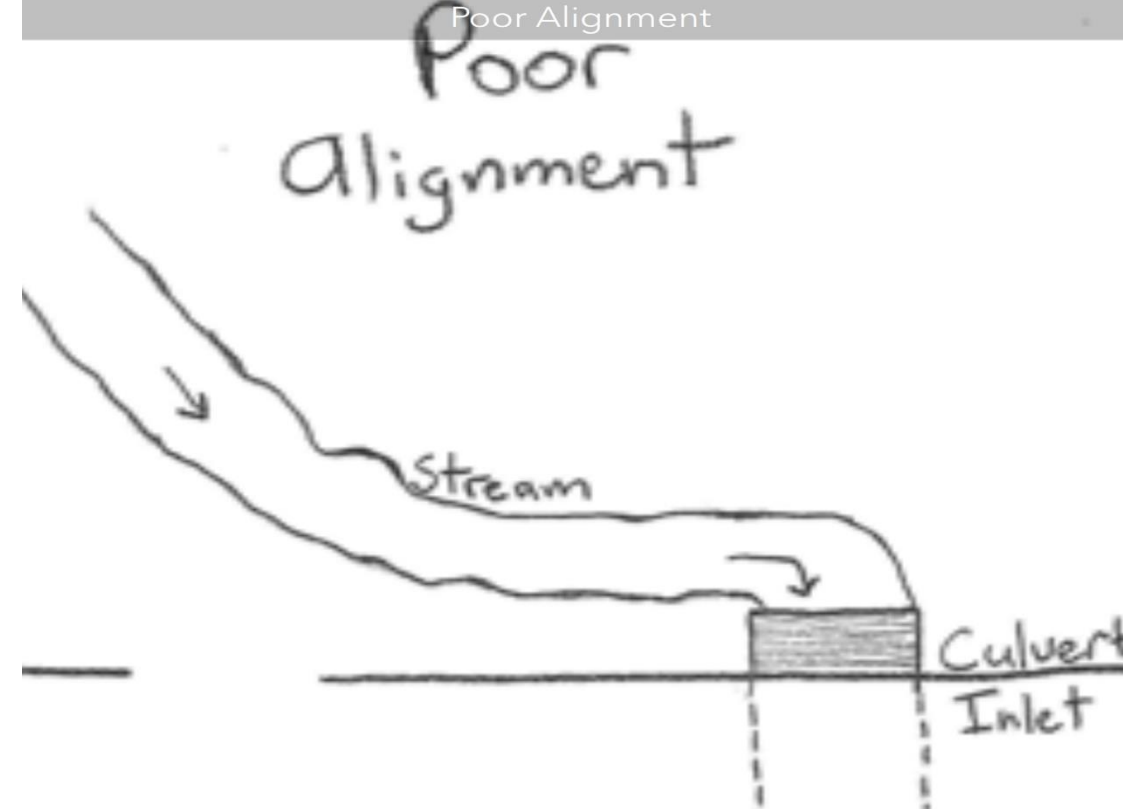
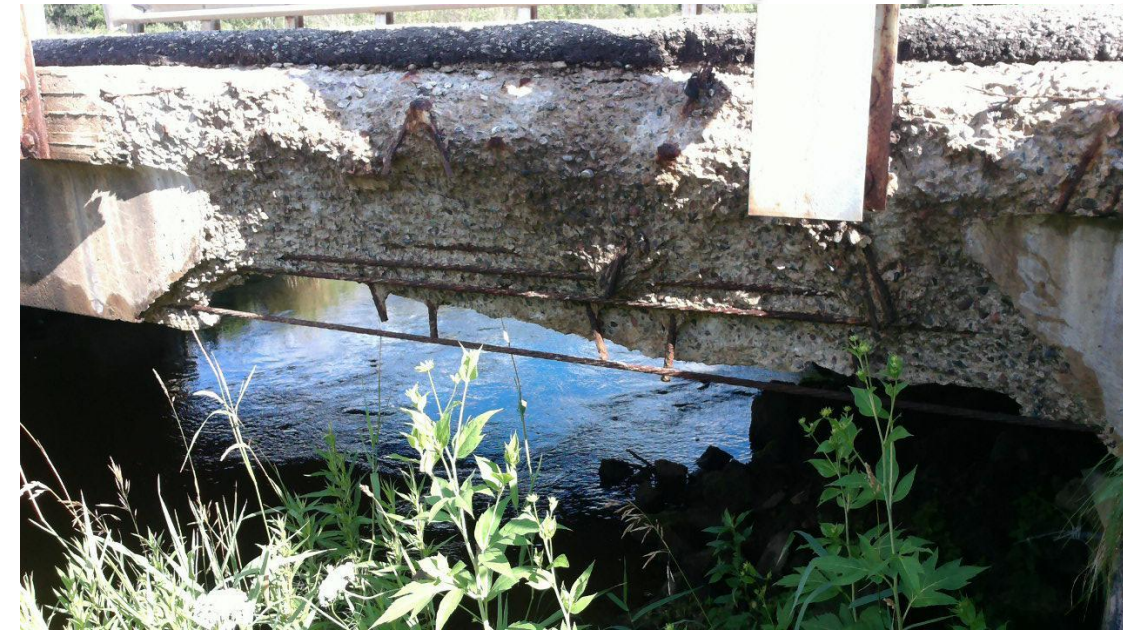
- There are several factors that can play a role in the condition of a structure, especially overtime
 - Alignment with stream
 - Site erosion totals
 - Armoring/RipRap/Wingwalls

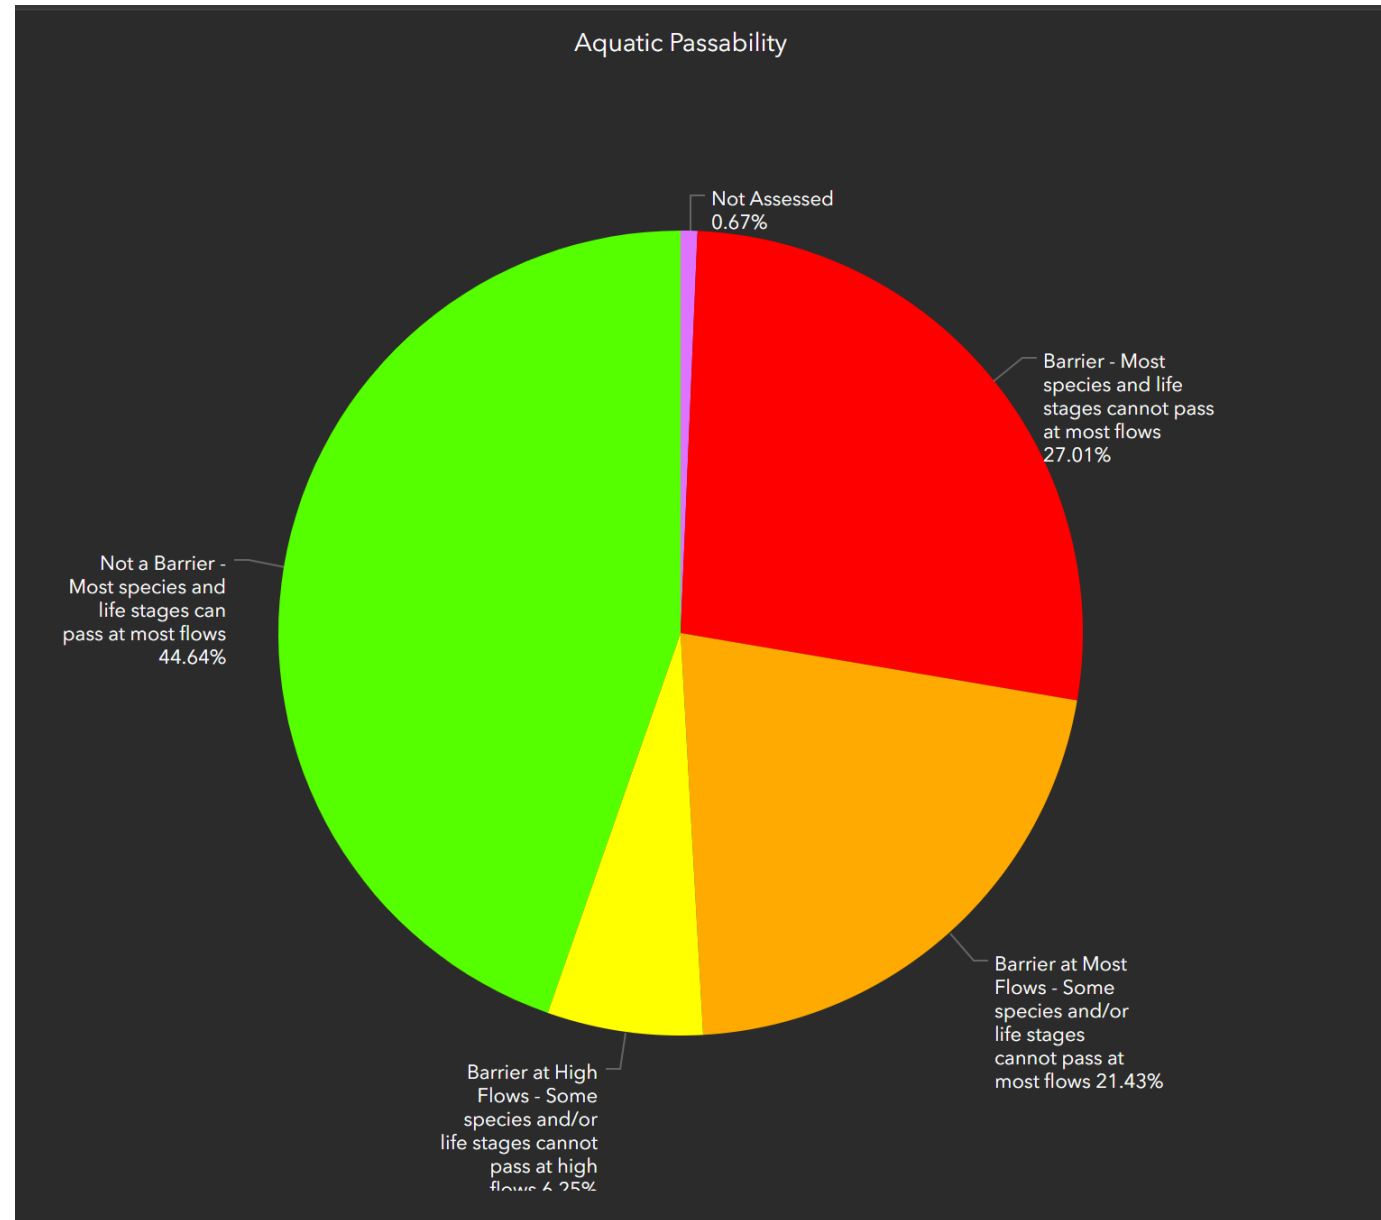
- 54.69% of crossings completed in Monroe County are barriers to fish at some or all flows
- Culverts are more likely to be a barrier than bridges
- Not all barriers found here are located in trout streams

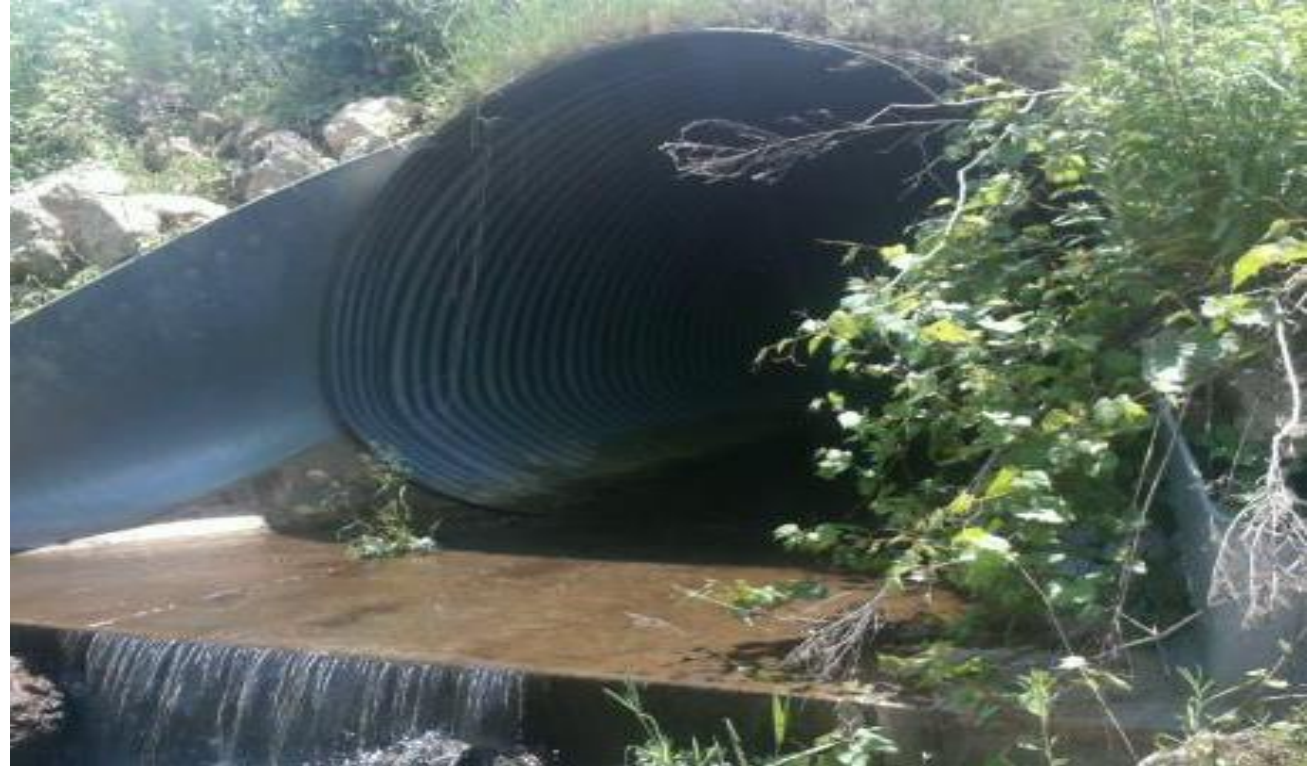
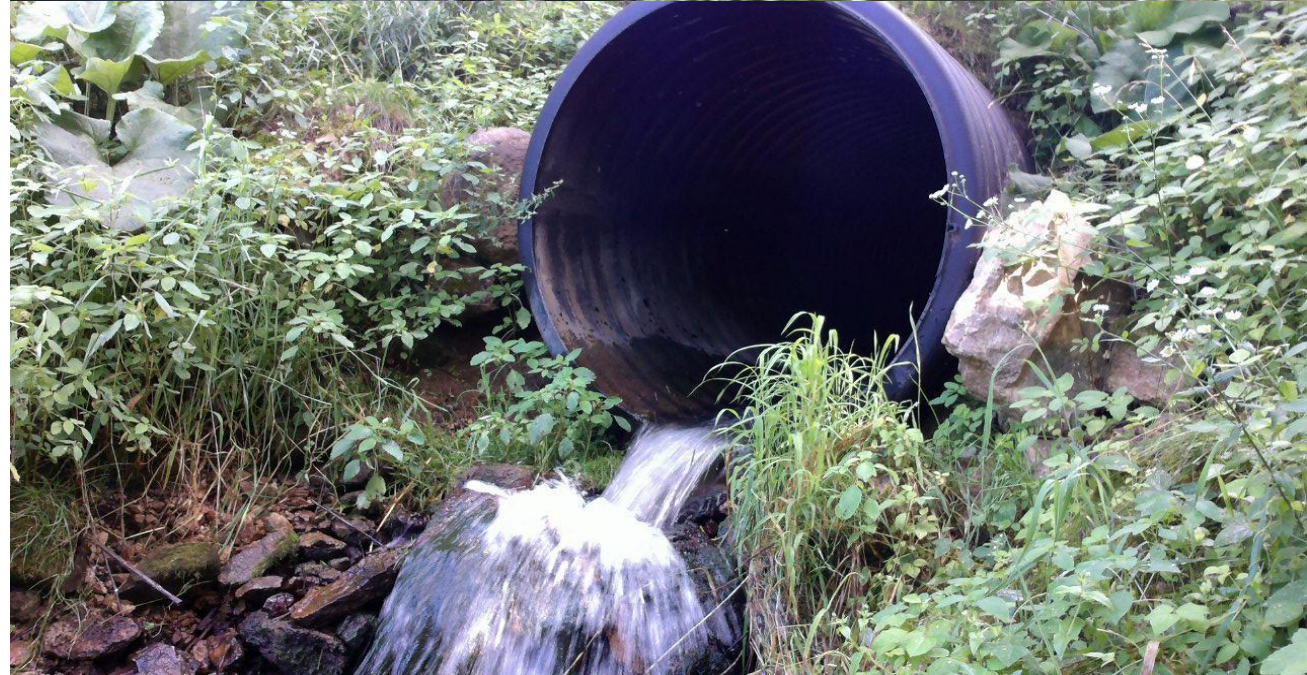
- Perch height
- Velocity
- Water level
- Structure shape

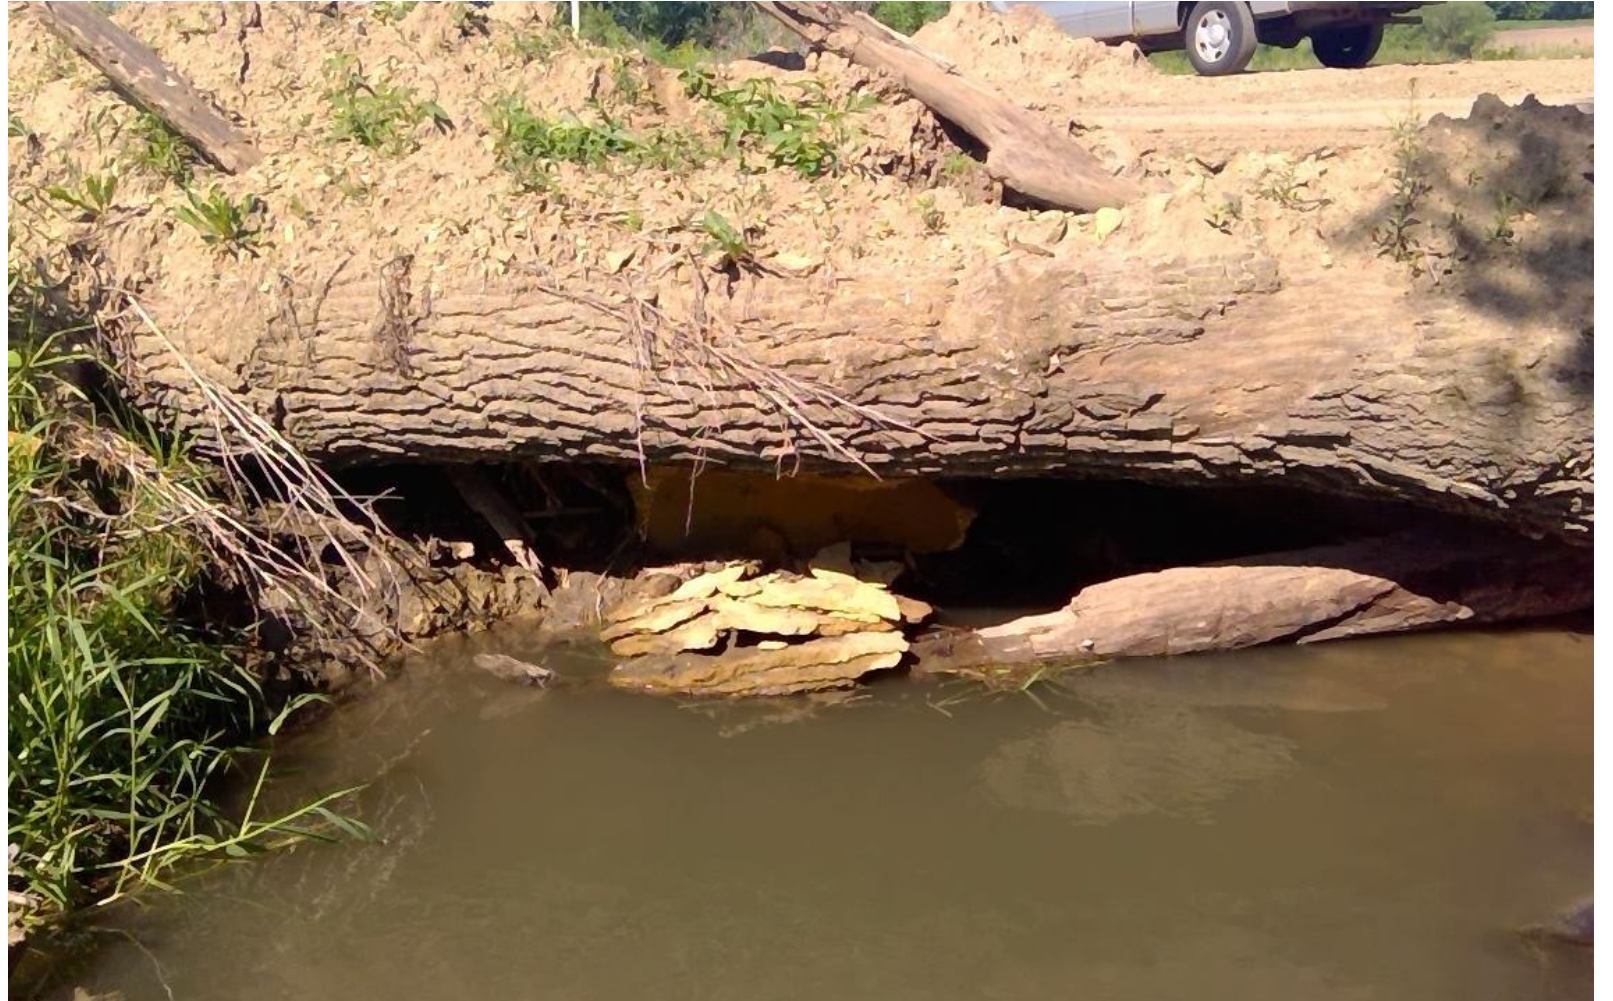
- Sizing standards
- Plugging or crushing
- Inlet armoring and riprap
- Structure alignment
- Diversion potential

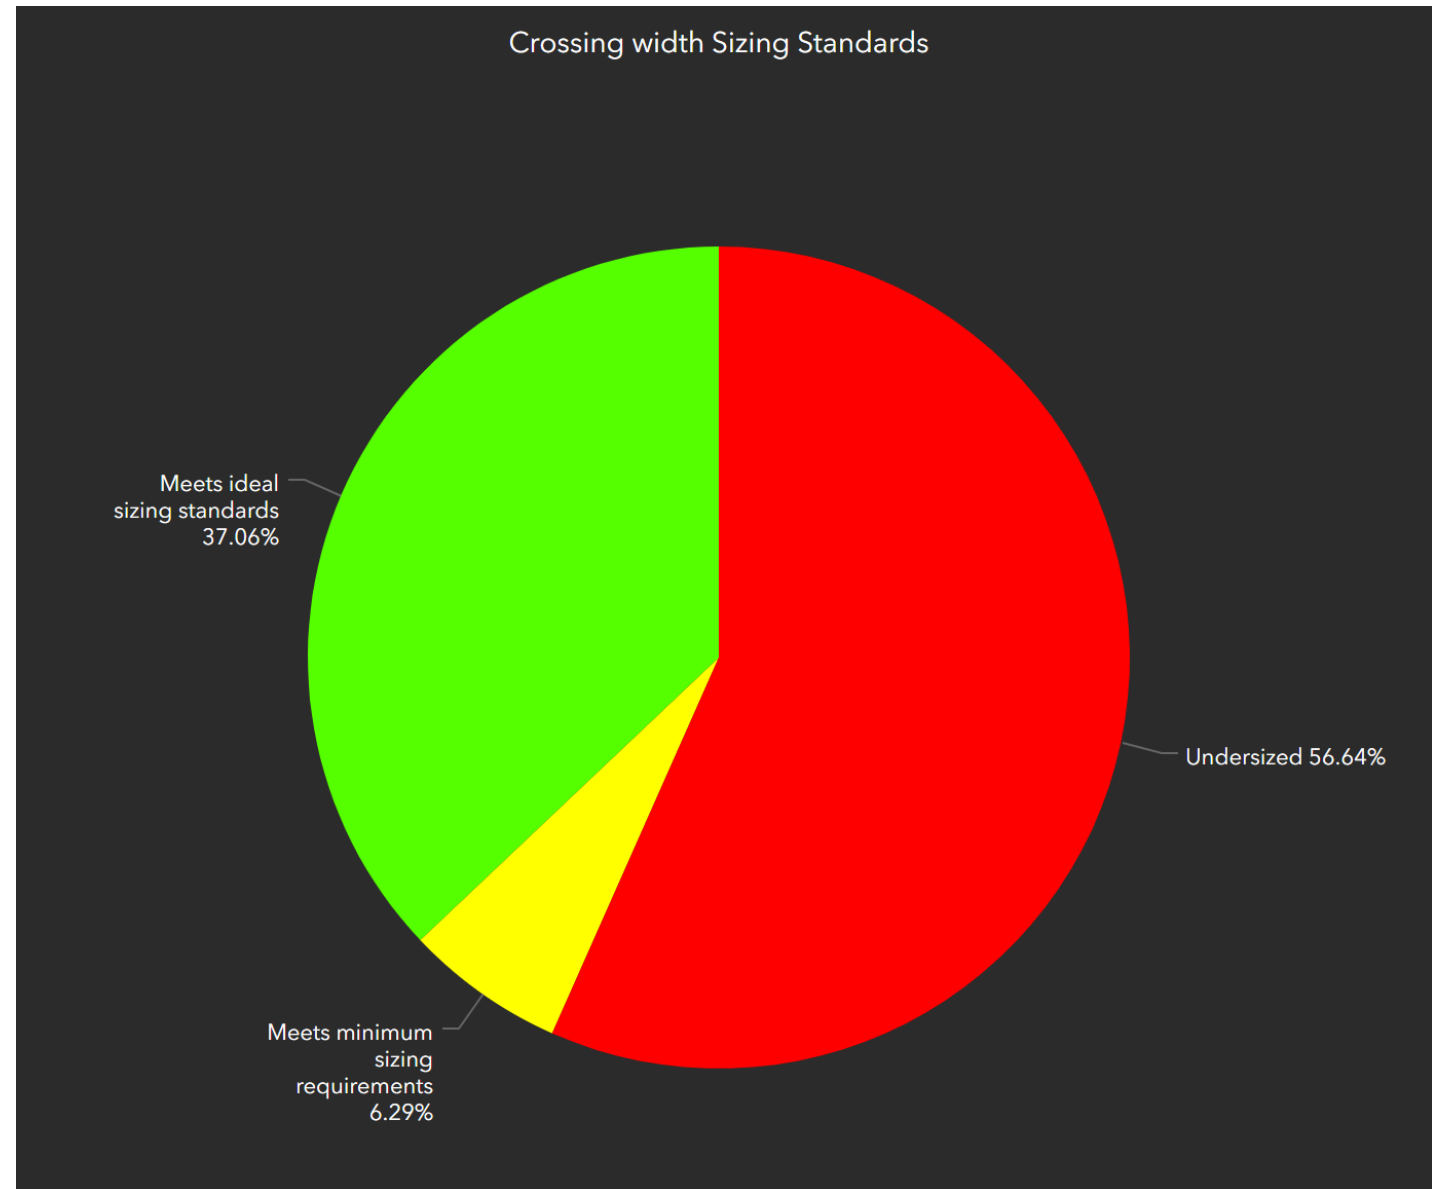
- 57% of crossings undersized
- water capacity
- premature deterioration
- 1.2 times bankfull width
- Seen more often in culverts than bridges
