U.S. Public Land Survey Monument Record

Corner ID: E1/4 Sec. 16, T15N-R1W

U. S. PUBLIC LAND SURVEY MONUMENT RECORD

SECTION 16, T15N, R1W, TOWN OF WELLINGTON MONROE COUNTY, WISCONSIN

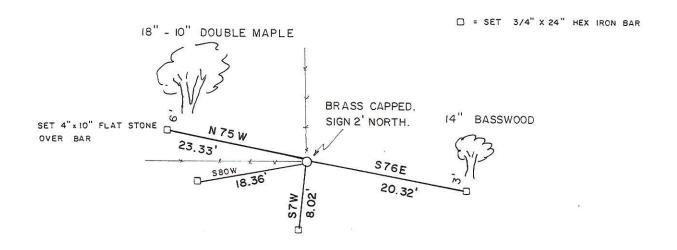
We found this 3/4" iron bar at an existing fence corner in 2007. We do not know its origin, but accepted it as the corner based upon best available evidence and used it for our survey in Vol 21 CSM P 95.

It was made known to me that a tie sheet had not been filed by previous surveyors. Found same 3/4" iron bar at fence corner and replaced it with brass capped monument. This is on a steep slope and very loose soil.
