U. S. PUBLIC LAND SURVEY MONUMENT RECORD

SECTION 31, T15N, R4W MONROE/VERNON COUNTY, WISCONSIN

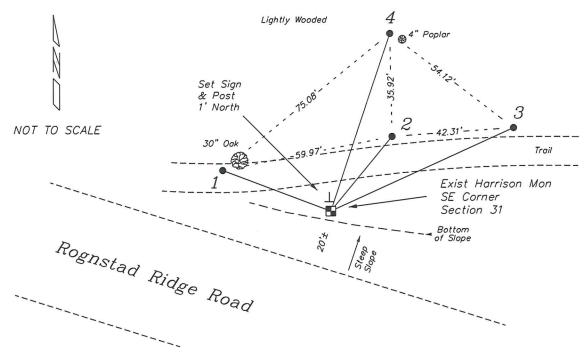
PLAN VIEW DRAWING OF REFERENCE TIES

NO	DESCRIPTION	BEARING	DISTANCE
1	Existing 3/4" Iron Rod 3' Southwest of a 30" Oak	N 69°20'06" W (N 74° W)	40.09' (39.93')
2	Set 3/4" x 18" Iron Rod 3' North of Road Edge	N 39°27'20" E	33.52'
3	Set 3/4" x 18" Iron Rod 3' North of Road Edge	N 65°31'16" E	69.77'
4	Set 3/4" x 18" Iron Rod 2' Northwest of a 4" Poplar	N 18°21'47" E	65.11'

- I found the Harrison monument set by Hayden and one of his ties.
- I found no evidence or reason to disagree with the location of the monument.

I accepted the Harrison monument as the best available evidence of the original government corner and added 3 new ties for reference.
