U.S. PUBLIC LAND CORNER MAINTENANCE

Corner ID: E1/4 Sec.12, T16N-R3W

21603122000

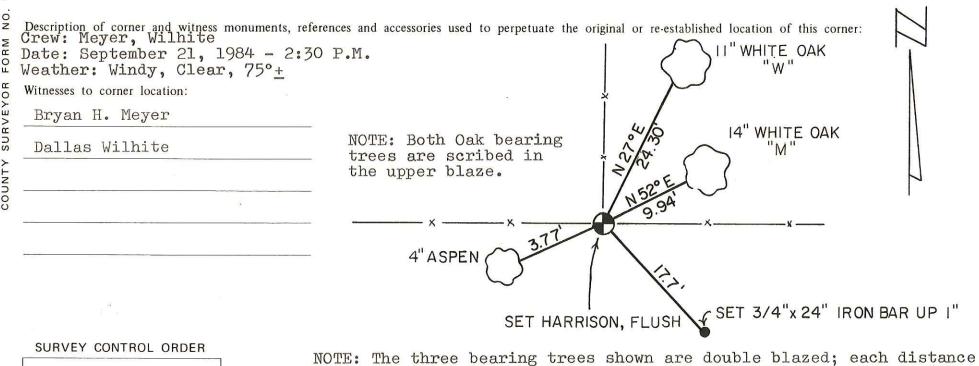
Description of corner evidence found:

Accepted 3-way fence corner as the best available evidence.

shown is to a nail set in a hack in the side of each tree. The bearings Horizontal shown are hand compass bearings. WISCONSIN COORDINATE SYSTEM Vertical North (Y) East (X) Elevation (Z) Zone Corner Control Sta. Name
