U.S. PUBLIC LAND CORNER MAINTENANCE

Corner ID: SW Sec.32, T16N-R3W

MONUMENT INFO

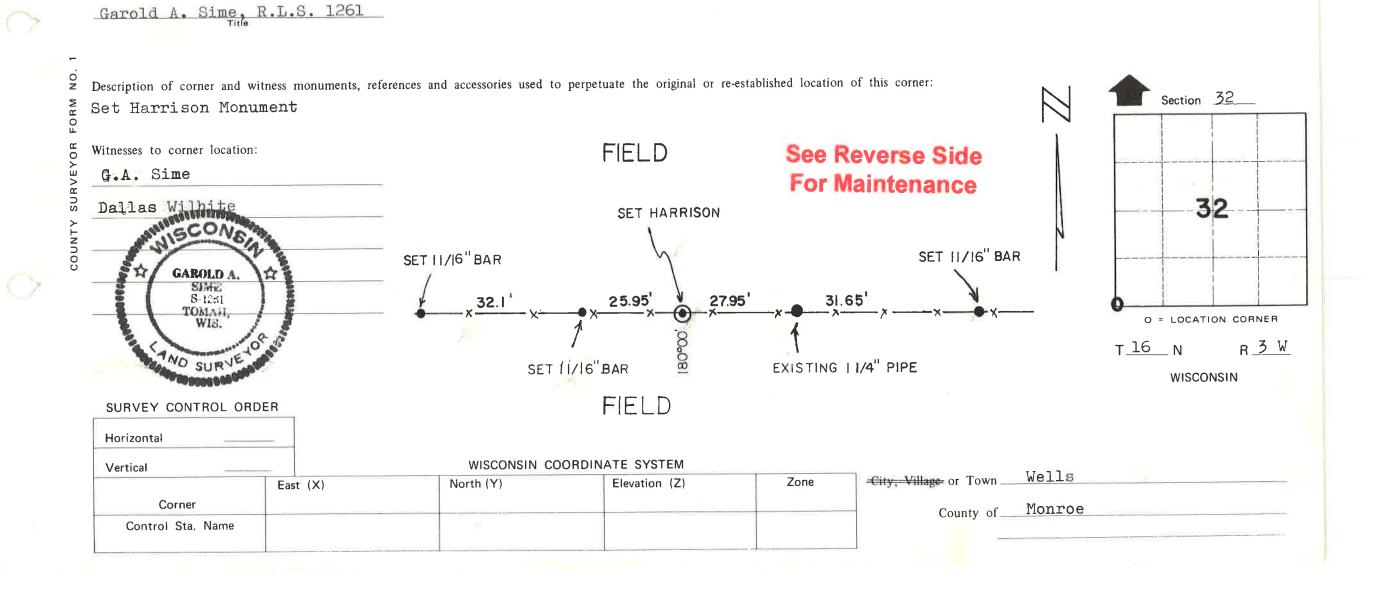
I set this corner on line with the West line of the NW% of Sec.32 projected south to intersect the existing fence line along the south line of the SEM-SEM, Sec.31. This location landed very close to the existing iron pipe(leaning) set by H.A. Sime.

March 24, 2020	Al Hoff Gary L. Dechant	Existing Harrison, top broke off, all fencing gone, now in tillable field			
			Ti de la companya de	Bearing	Distance	
1)	Reset disturbed 1	1/16" in field, set down 10"		N89°42'19"W	26.31' (25.95')	
<u>2)</u>	Reset disturbed 1	1/4" iron pipe in field, set down 10"		N89°53'24"E	27.77' (27.95')	
<u>3)</u>	Set 3/4"x24" rou	nd iron bar in field, down 10"		S31°24'42"E	23.67'	
<u>4)</u>	Reset disturbed 1	1/16" round iron bar in field, set do	wn 10"	S89°59'34"E	59.77' (59.60')	
<u>5)</u>	Set 3/4"x24" rou	nd iron bar in field, down 10"		N19°32'36"W	30.85'	
		٨	1 4	-
