## U.S. LAND CORNER MAINTENANCE

**Corner ID**: S1/4 Sec.32, T18N-R1E

41801320020

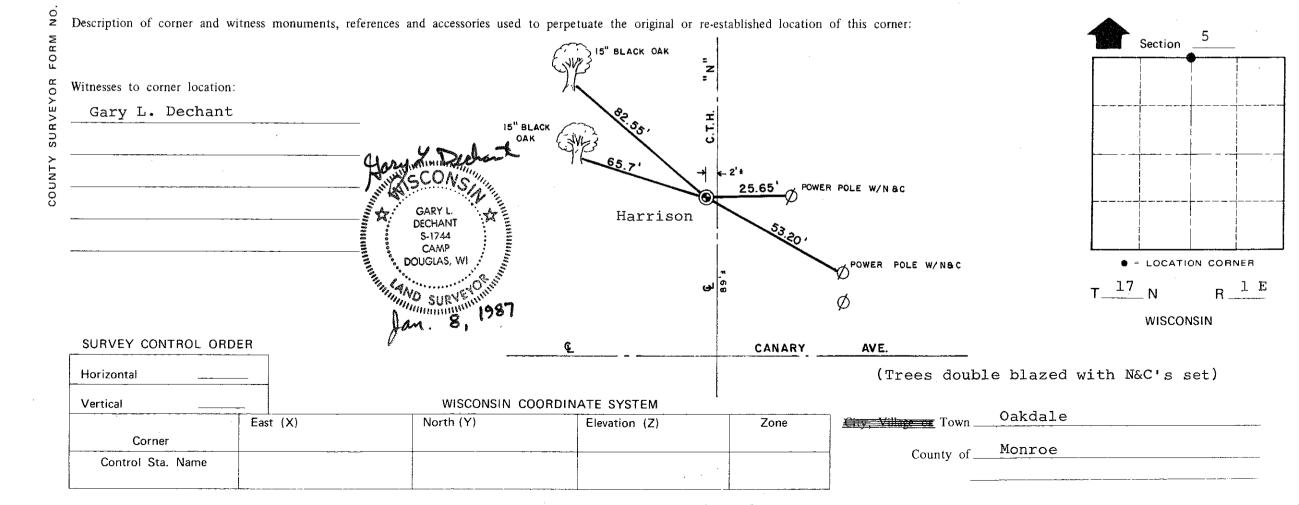
Description of corner evidence found:

Could not find iron pipe, set corner on a straight line and at prorated distance between section corners.
