**U. S. Public Land Corner
Maintenance**

**Corner: NW Sec. 18, T17N-R1E
21701120000**

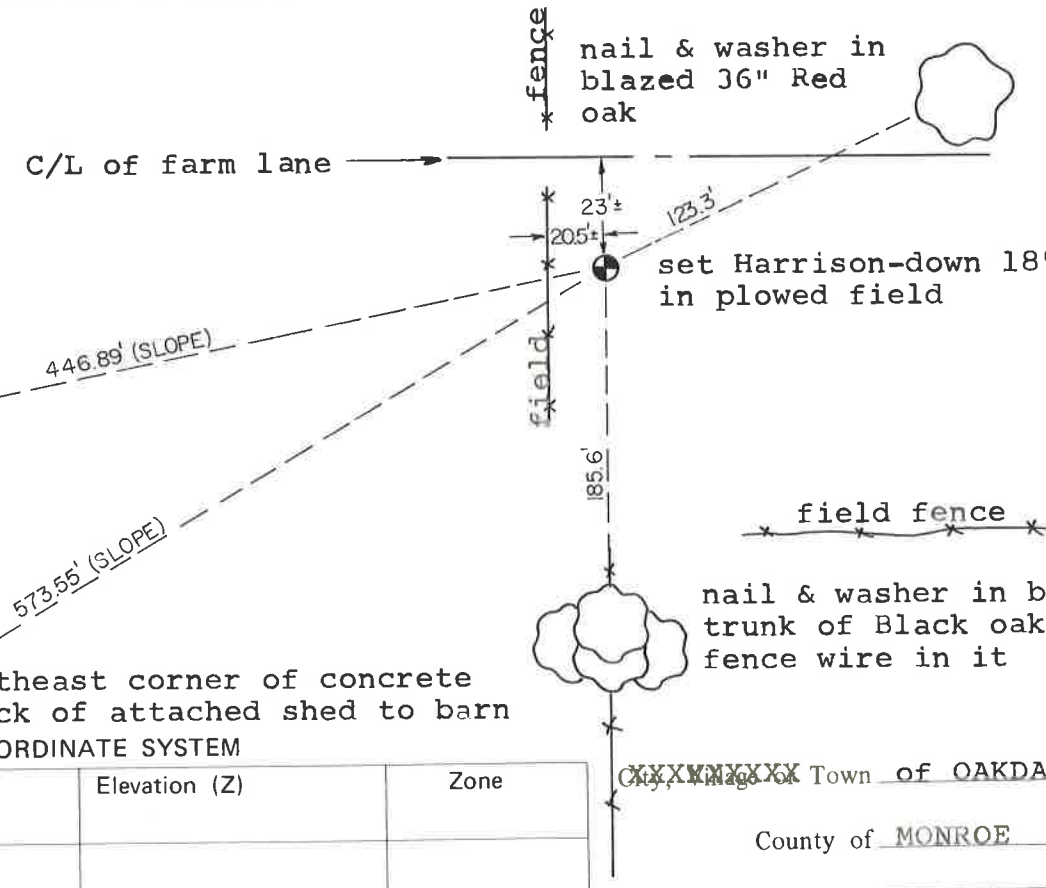
T 17 N R 1 E

O = LOCATION CORNER

This corner was set with the help of the landowner, Roy Rasch, on whose land the corner falls. The corner was set in the extension of the fence to the South and to the North. The old section line fence was taken out by Mr. Rasch in this area. The extension of these fences and the intersection of the abandoned fence line from the West, as per Mr. Rasch's recollection of this fence line, was considered as the corner. This corner checked within tolerances of the Government Survey Notes.
