RECORD OF SURVEY.

Plat of Section Two, Township 17 North, Range 2 ~~East~~ ^{West} of Four
Principal Meridian, Scale 80 Chains to 6 2/3 inches.

Surveyed NOVEMBER A. D. 1940, in accordance with
the State Laws and Instructions of the Commissioner of General Land Office.

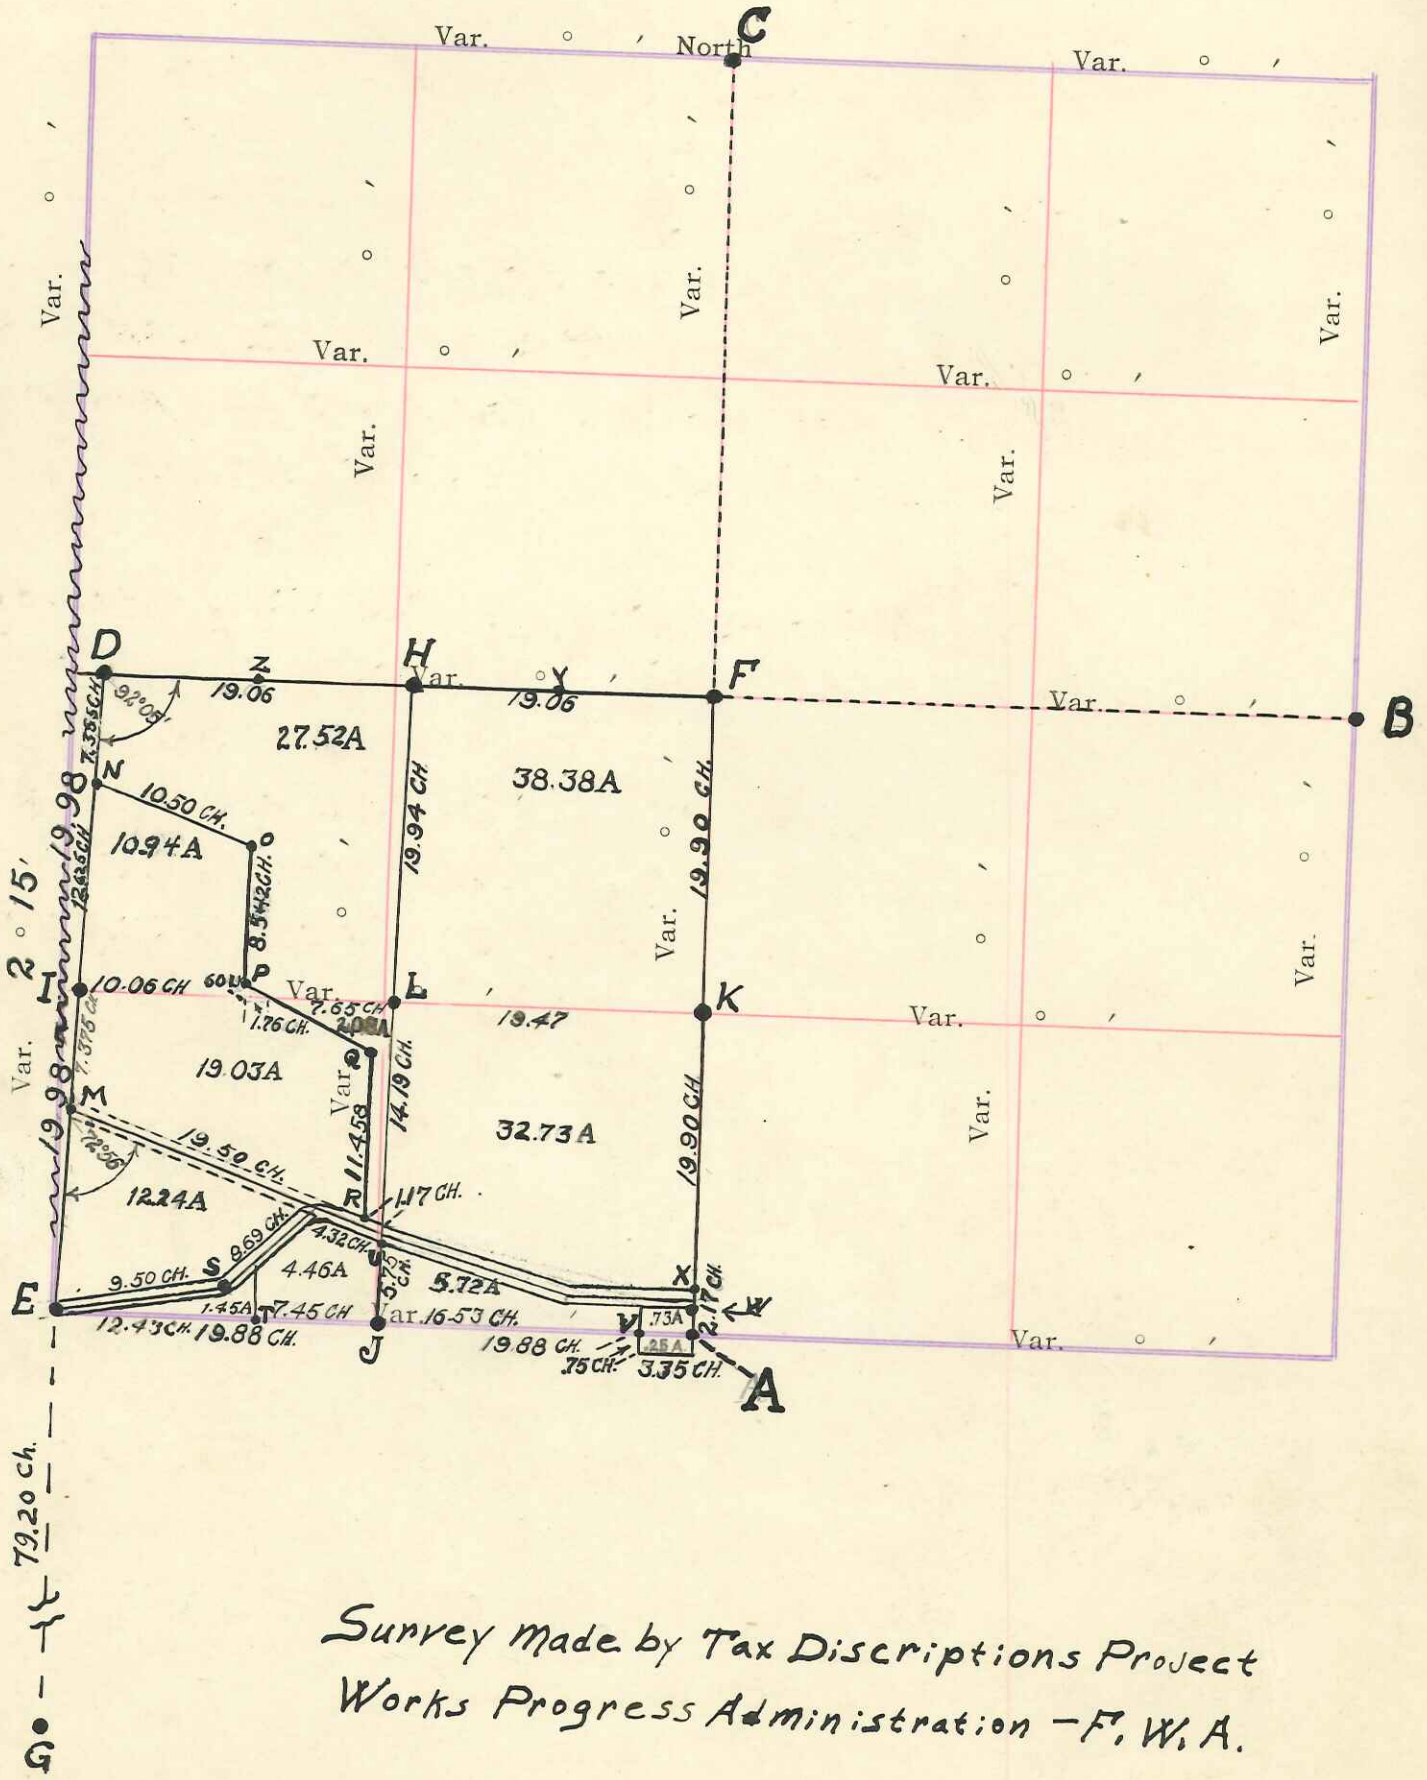
(A) S. 1/4 CORNER. FOUND DECAYED BOTTOM OF OLD COR. FENCE POST ON LINE OF FENCES N.S. AND W. ALSO FOUND 12" B. OAK TREE GROWING OUT OF OLD STUMP AT RIGHT COURSE AND DISTANCE FOR S.W. B.T. COULD NOT FIND ANY TRACE OF N.E. B.T. SET AUTO STEERING POST. UP 18"

(B) E 1/4 COR. FOUND 1 1/4" X 28" PIPE, UP 4" SET IN FORMER SURVEY AT INTERSECTION OF FENCES NE. W.S. ALSO FOUND DECAYED REMAINS OF W. OAK STUMP AT RIGHT COURSE AND DISTANCE FOR N.E. B.T. COULD NOT FIND ANY TRACE OF S.W. B.T. DROVE AUTO DRIVE SHAFT INSIDE PIPE, UP 18"

(C) N. 1/4 COR. FOUND W. OAK TREE GROWING OUT OF OLD STUMP AT RIGHT COURSE AND DISTANCE FOR N.E. B.T. FROM INTERSECTION OF FENCES NE. W.S. ALSO FOUND DECAYED ROOTS OF LARGE W. OAK AT RIGHT COURSE BUT 4 LINKS LESS THAN DISTANCE FOR W. B.T. ERROR EVIDENTALLY CAUSED BY STEEP SLOPE. SET AUTO STEERING POST AT CORNER, UP 18"

D - W. 1/4 Cor. - Found Stumps of both B.Ts. (Marks plain on N.E. Stump) at right course and distance from decayed point of old Stake in ground near intersection of fences N.E. & S. Set Auto. Steering Post at Cor., up 12"

G - Cor. Sec's. 10-11-14-15 - Found Stone at Cor. of fences N.-S. & W., also evidence of roots of S.W. B.T. at right course and distance. E. of Hiway is 2.60 ch. N. of Cor. Set Auto Torque Tube, up 1', beside Stone at Cor.
