U.S. PUBLIC LAND CORNER MAINTENANCE

Corner ID: SE Sec. 18, T15N-R1E

41501180000

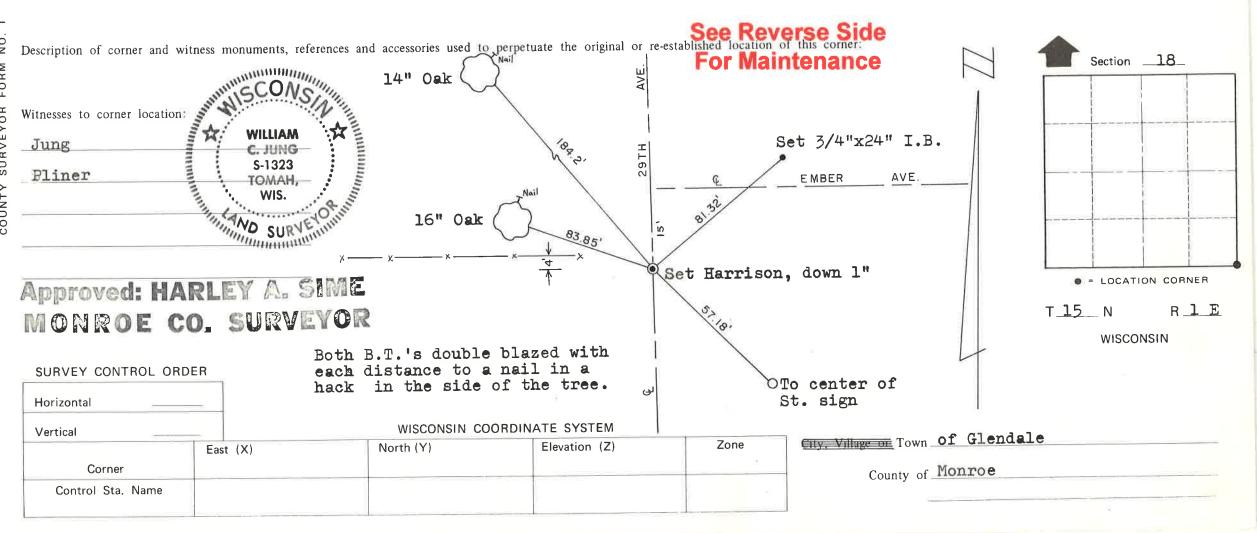
History of corner establishment since Original Government Survey

O. R. Dahl was at this corner in December of 1868. Holden found the original corner here in November of 1907. Apparently he set an iron pipe here as shown in some unrecorded field notes.

Description of corner evidence found:

I dug and searched but could not find Holden's iron. I set the corner on line with Holden's iron pipe at the El/16SE and the fence corner at the NE Corner, and at a distance from the El/16SE equal to 1/3 of the distance between the El/16SE and the NE Corners. The road centerline to the North is thus almost perfectly on the section line as it should be according to the old Town Road Records. This location also fits other evidence in all (4) cardinal directions very well.
