U. S. PUBLIC LAND SURVEY MONUMENT RECORD

SECTION 11, T15N, R1E, TOWN OF GLENDALE
MONROE COUNTY, WISCONSIN

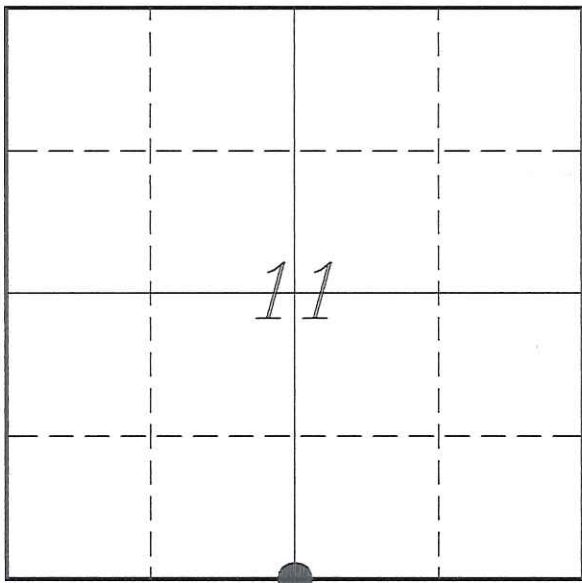
LOCATION OF LANDMARK

The government notes show that there is a creek, 1.98 chains (130.68') to the East of this corner. The current creek crosses the fence line at a distance of 110'±. The creek lies within a flat area and it is difficult to tell if it has moved or not.

This location is 41.2' South and 26.6' East of the mid-point between the SW & SE Corners.

The fence in this area is somewhat erratic, most likely due to the rock wall located along the West side of the creek. Though it has been maintained by land owners and accepted as the property lines.

Since Dechant used this location to establish the Center of Section and several interior '40' Corners based off this location, I decided to accept the 3/4" iron rod as the best available evidence of the original government corner and replaced it with a Harrison Monument.

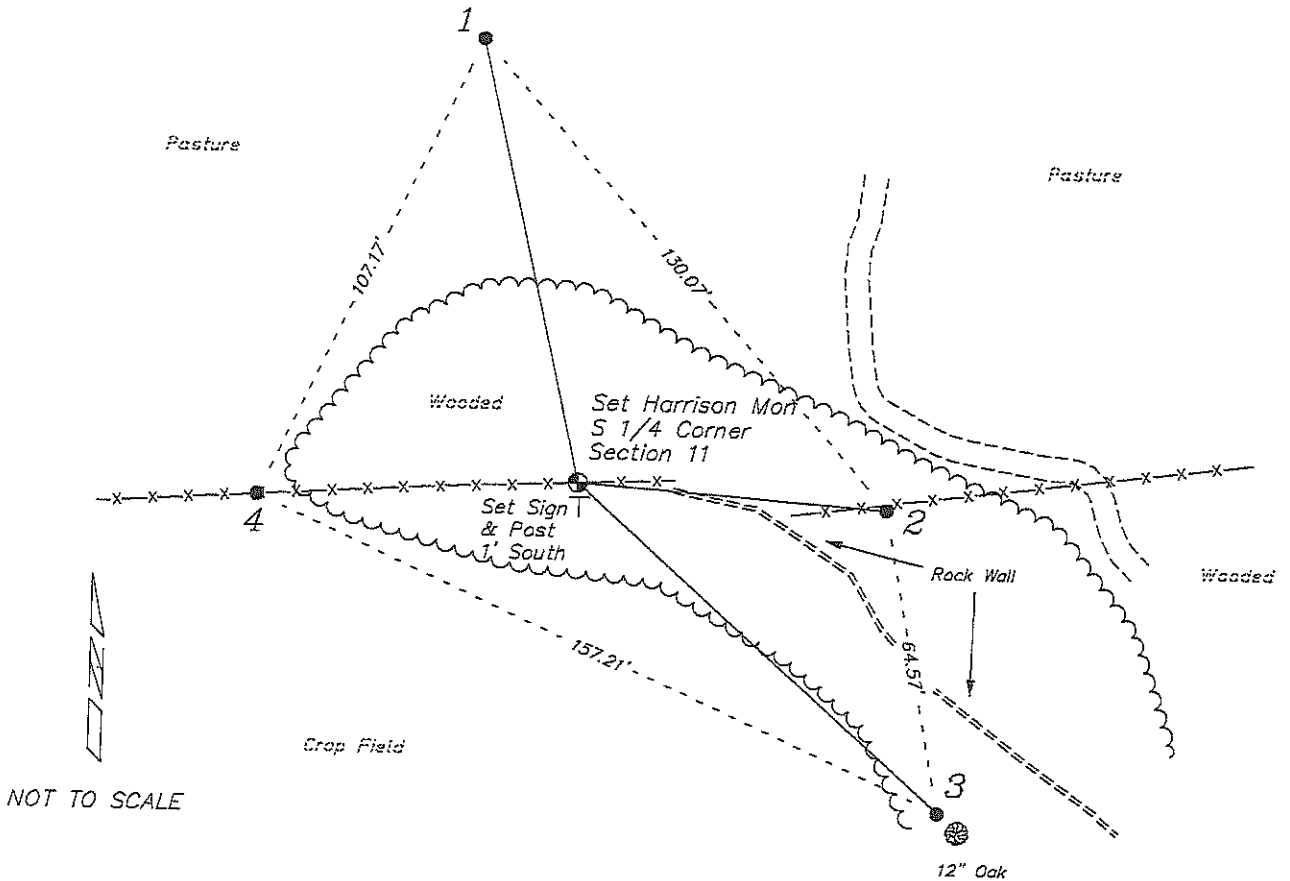
PLAN VIEW DRAWING OF REFERENCE TIES

NO	DESCRIPTION	BEARING	DISTANCE
1	Set 3/4" x 18" Iron Rod In Pasture - Flush with Ground	N 12°44'41" W	95.71'
2	Set 3/4" x 18" Iron Rod In Fence Line	S 85°59'24" E	64.71'
3	Set 3/4" x 18" Iron Rod 2' North of a 12" Oak	S 48°27'34" E	102.46'
4	Set 3/4" x 18" Iron Rod In Fence Line	S 86°53'54" W	66.86'
